Grand Lake St Marys Saturated Buffer Monitoring Summary

St Charles Center Saturated Buffer Design

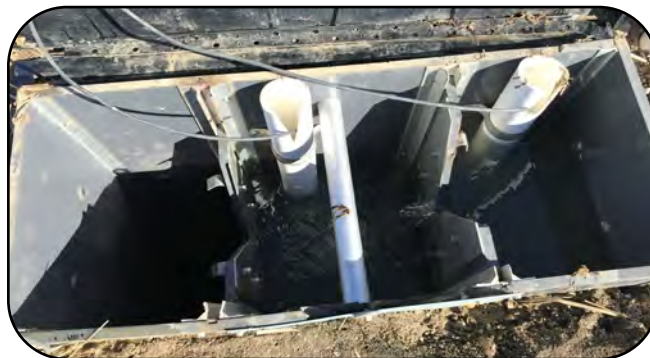
* Overhead view of 3-chamber box actively charging—note water flowing over first stop log (right) from the field and no water flowing over the second stop log (left) indicating an active charge event

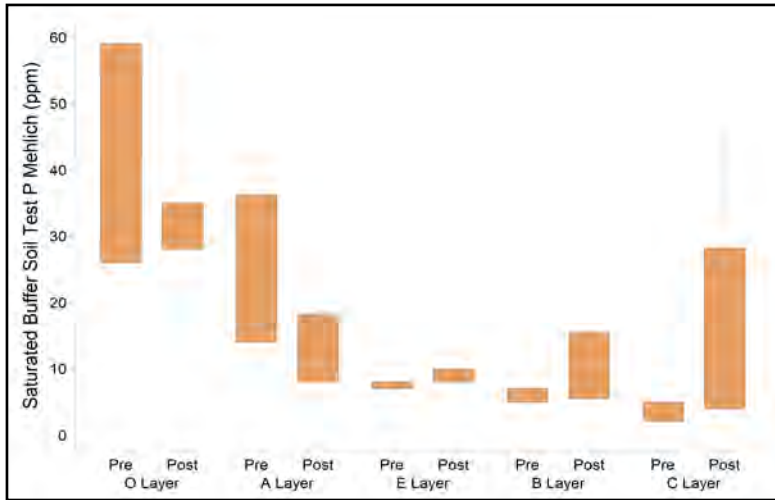
* Soil test phosphorus levels arranged by increasing depth of soil strata before and after study

- Soil test P levels in the buffer exhibited a decline over the monitoring period near the surface and an increase in deeper layers—likely indicating uptake from surface plants and deposition (adsorption) of P into the subsurface.
- Factoring in Aluminum and Iron, soil P storage capacity statistics (SPSC) were all positive indicating likelihood of additional P capacity in the buffer.
- Unfortunately, STP levels in the field adjacent the riparian went up in the surface horizons (O & A)—and while positive SPSC values indicate that this is technically still a P sink—it does signal potential problems in the future.

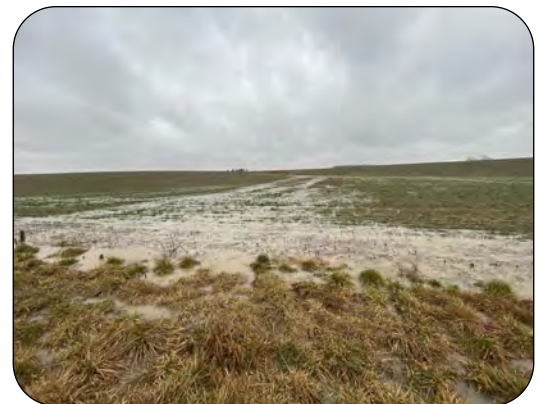
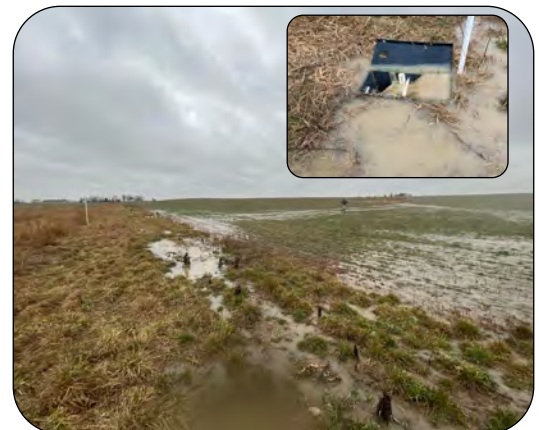
* Surface runoff event—note concentrated flow area leaving study field and flowing through restored buffer area prior to discharging into the adjacent Beaver Creek

- Given the elevation of the control box coupled with the depth loggers and field observations, it was possible to estimate how many surface runoff events occurred over the study. In 2021, surface runoff occurred 7 times with 3 being 'large' events lasting 12 hours or more. In 2022, surface runoff occurred 5 times with 1 being a 'large' event lasting more than 12 hours.
- Despite these surface events, we are encouraged by the overall reduction in surface P loading as a result of the restored buffer.
