# Building a Sustainable Community in Africa

Water Sustainability at the Mpala Research Centre and Conservancy

**A PROJECT SUBMITTED IN PARTIAL FULFILLMENT OF THE REQUIREMENTS FOR THE  
DEGREE OF MASTER OF SCIENCE (NATURAL RESOURCES AND ENVIRONMENT) AT THE  
UNIVERSITY OF MICHIGAN**

2011

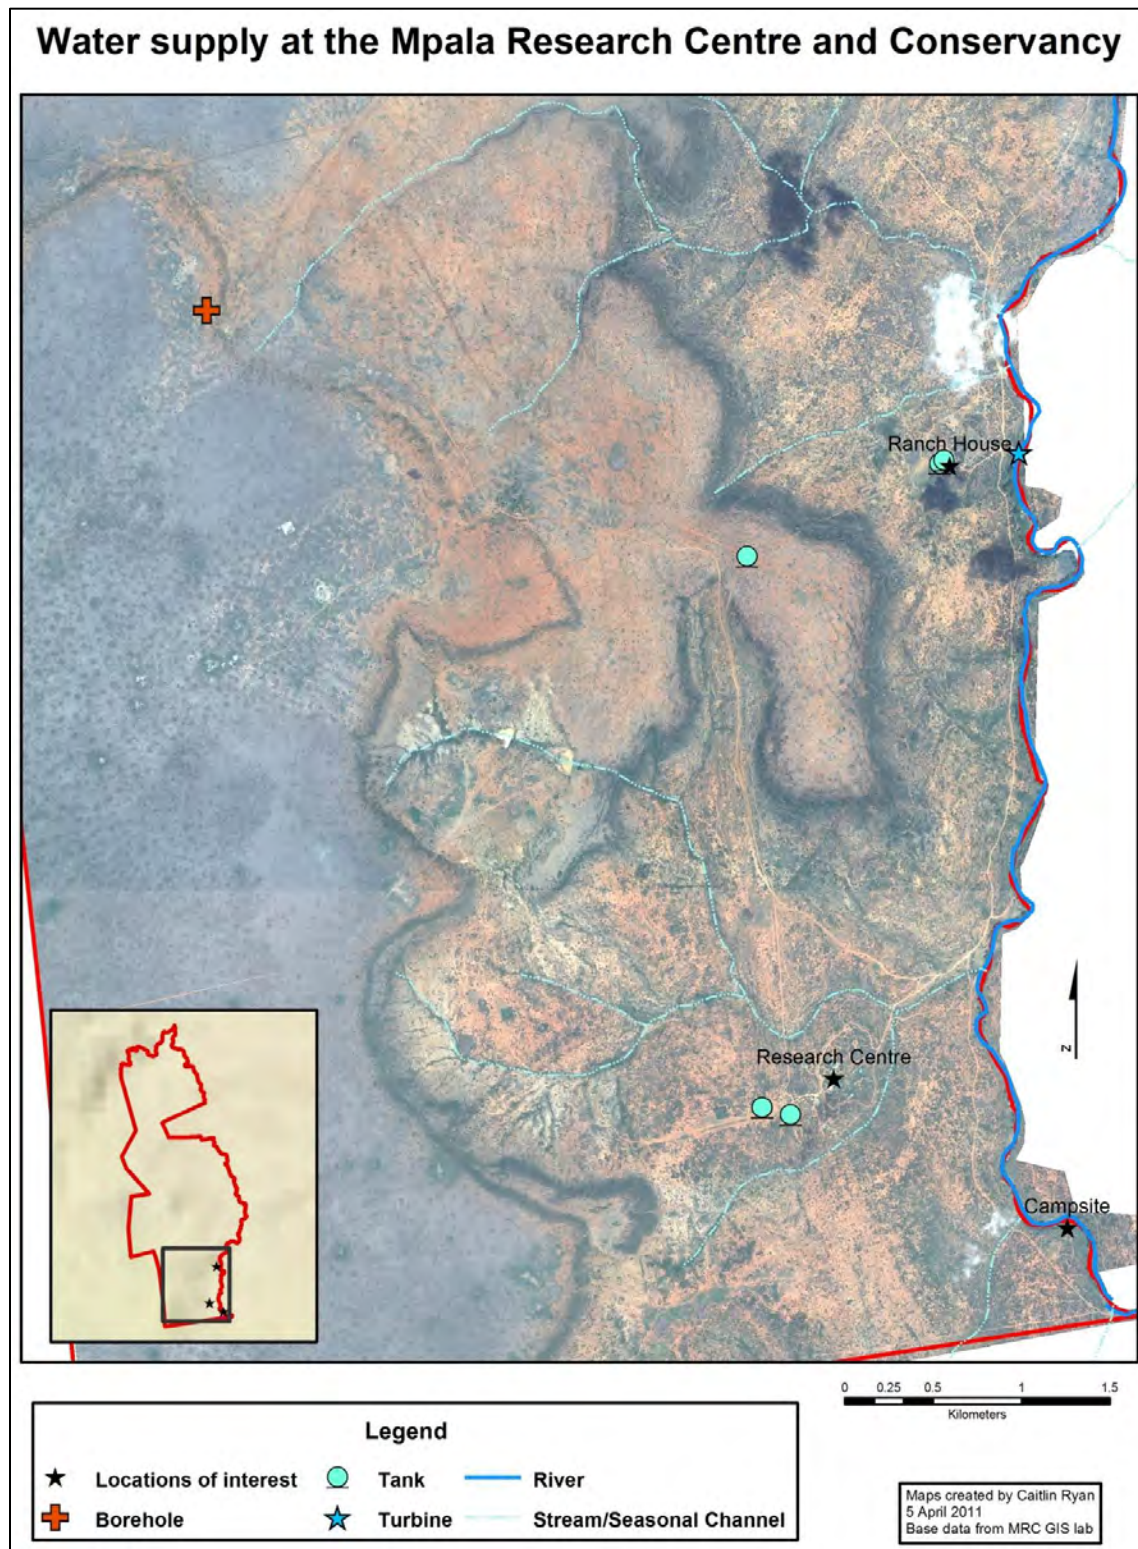
FIGURE 2: WATER SUPPLY AT MPALA

There are three main sources of water at Mpala – river, rainwater storage, and borehole (Figure 2). The first two are dependent upon current weather and rainfall. The latter is an ancient and finite supply, with its imperfections and challenges, but whose supply is not dependent upon the current weather conditions. The challenge that Mpala faces is to identify which source, or combination of sources, is ideal to supply water for their daily needs and to minimize water stress during times of drought.

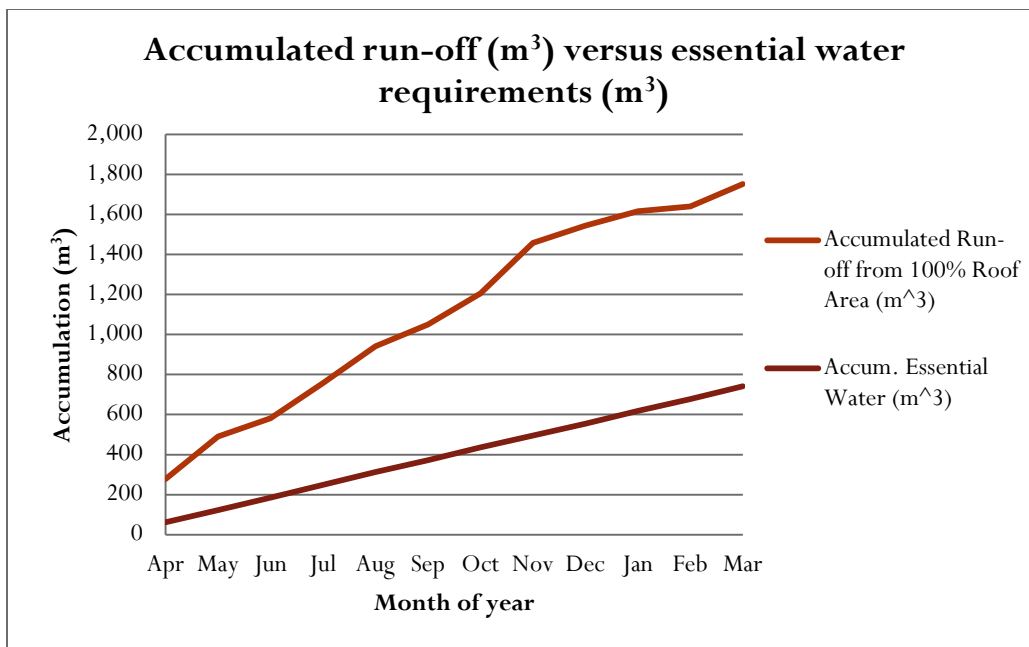
FIGURE 3: ACCUMULATED RUNOFF (M3) FROM ENTIRE ROOF AREA AND ESSENTIAL WATER REQUIRED (M3) FOR CURRENT POPULATION

On the following page, you will find two examples of the graphs provided, with the remainder found in Appendix W-3. The first, Figure 3 illustrates accumulated storage for the total roof area in an average rainfall year and accumulated current essential consumption demands. The second graph, Figure 4, illustrates accumulated storage for the current roof area available for collection in a low rainfall year and accumulated projected essential consumption demands.

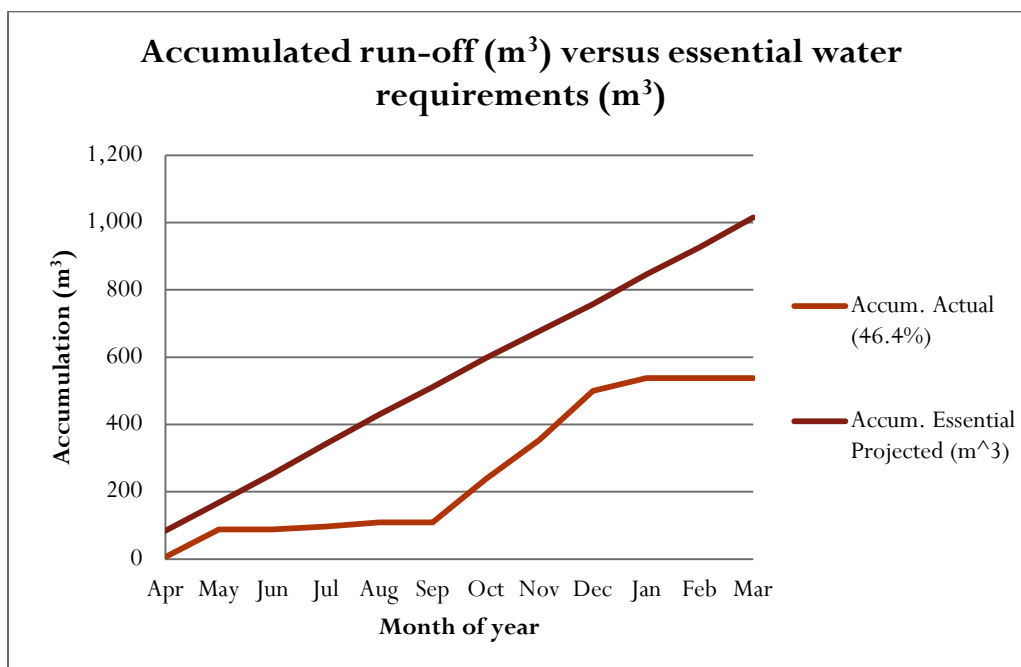
FIGURE 4: ACCUMULATED RUNOFF (M3) FROM CURRENT ROOF AREA CONVERTED TO CAPTURE WATER AND ESSENTIAL WATER REQUIRED (M3) FOR PROJECTED FUTURE POPULATION

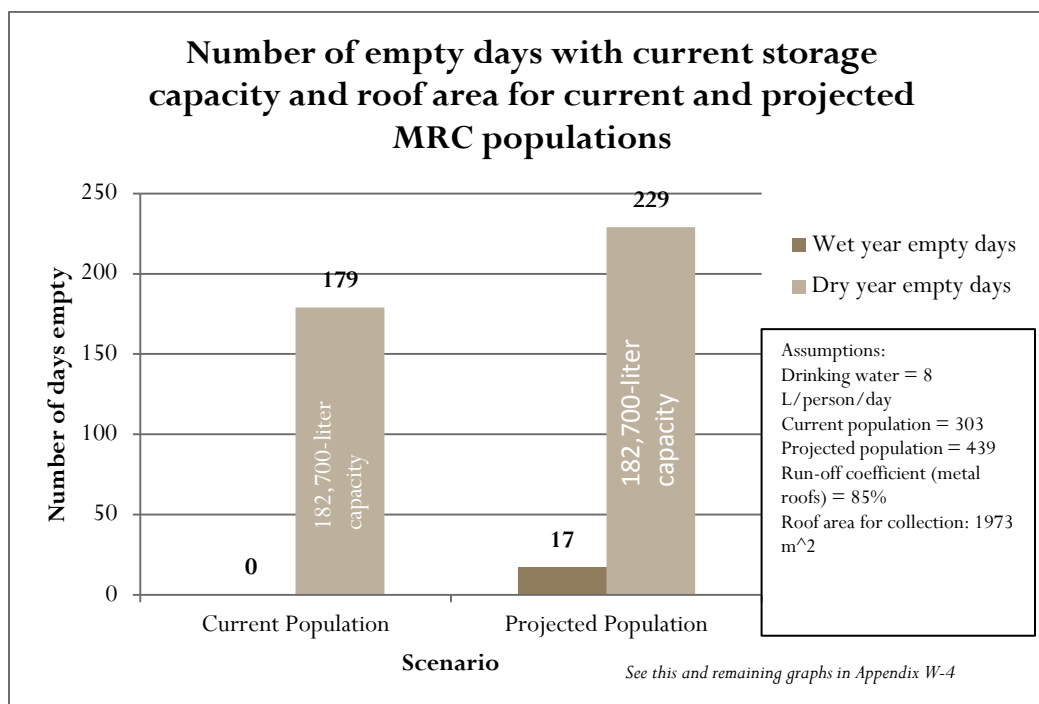
FIGURE 5: COMPARISON OF CURRENT STORAGE CAPACITY AND ROOF CATCHMENT SERVING CURRENT AND PROJECTED TOTAL MRC POPULATION

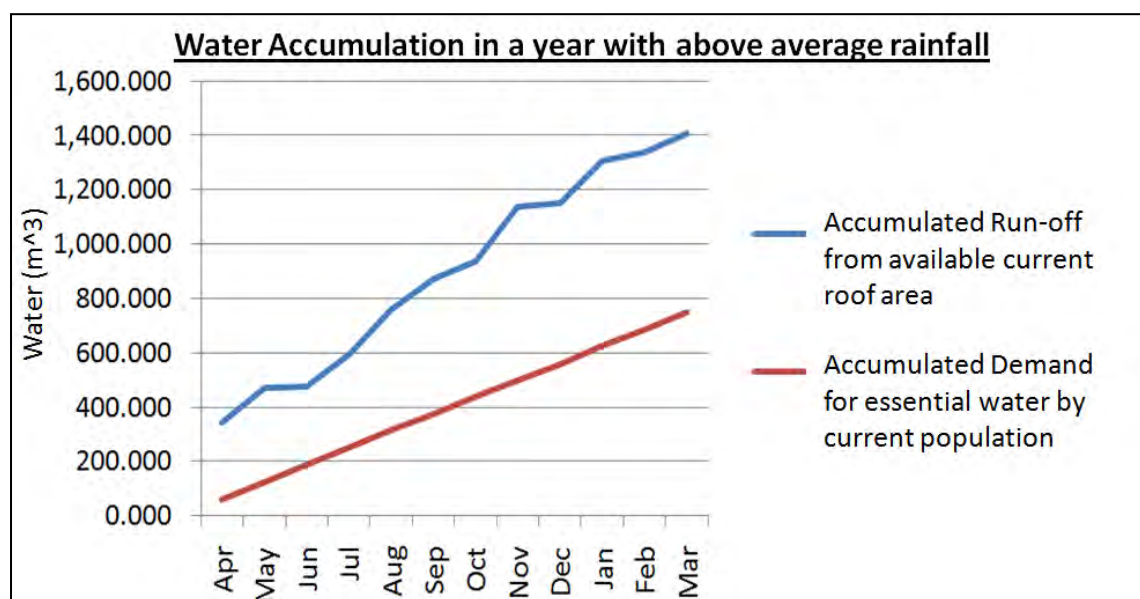
FIGURE 6: ACCUMULATED WATER RUNOFF IN A WET YEAR (M<sup>3</sup>) FROM CURRENT CONVERTED ROOF AREA VERSUS ACCUMULATED DEMAND (M<sup>3</sup>) BY CURRENT POPULATION

As you can see in Figure 6, the total accumulated run-off potential at Mpala during a wet year with the current roof catchment systems in place is over 1.4 million liters or 1400 cubic meters. Accumulated demand over a year for essential water is only around 800,000 liters or 800 cubic meters. That would provide an opportunity to store the excess 600 cubic meters for a dry year.

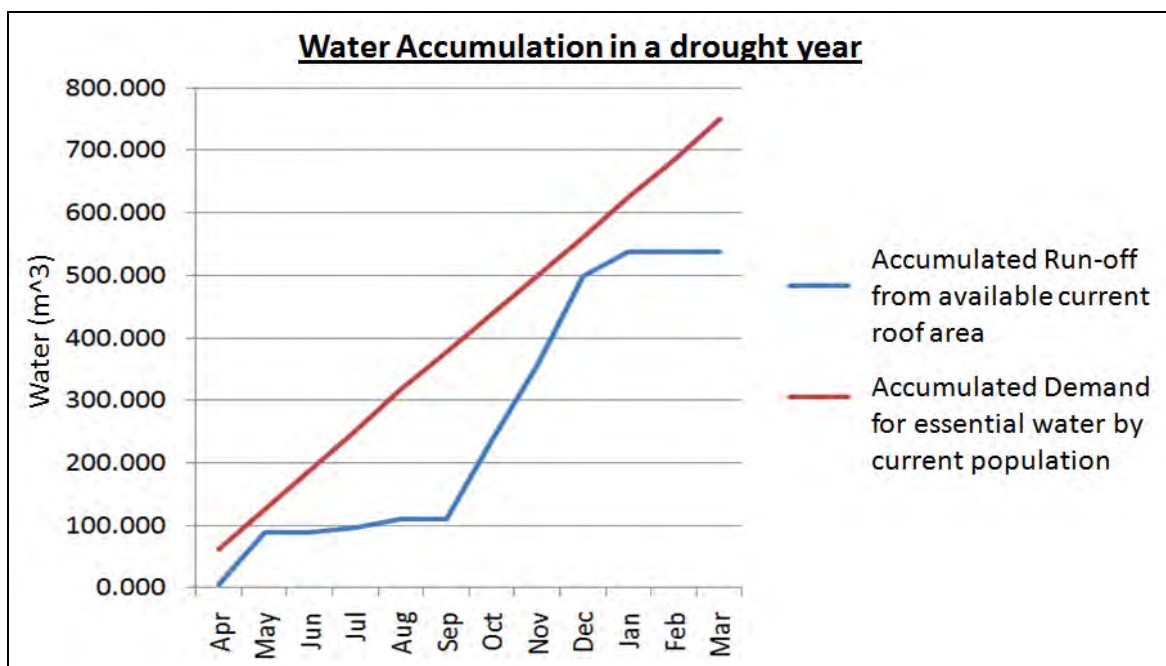
FIGURE 7: ACCUMULATED WATER RUNOFF IN A DROUGHT YEAR (M3) FROM CURRENT CONVERTED ROOF AREA VERSUS ACCUMULATED DEMAND (M3) BY CURRENT POPULATION

Figure 7 (below) is an example of what the gap between supply and demand may be during a typical dry year at Mpala.

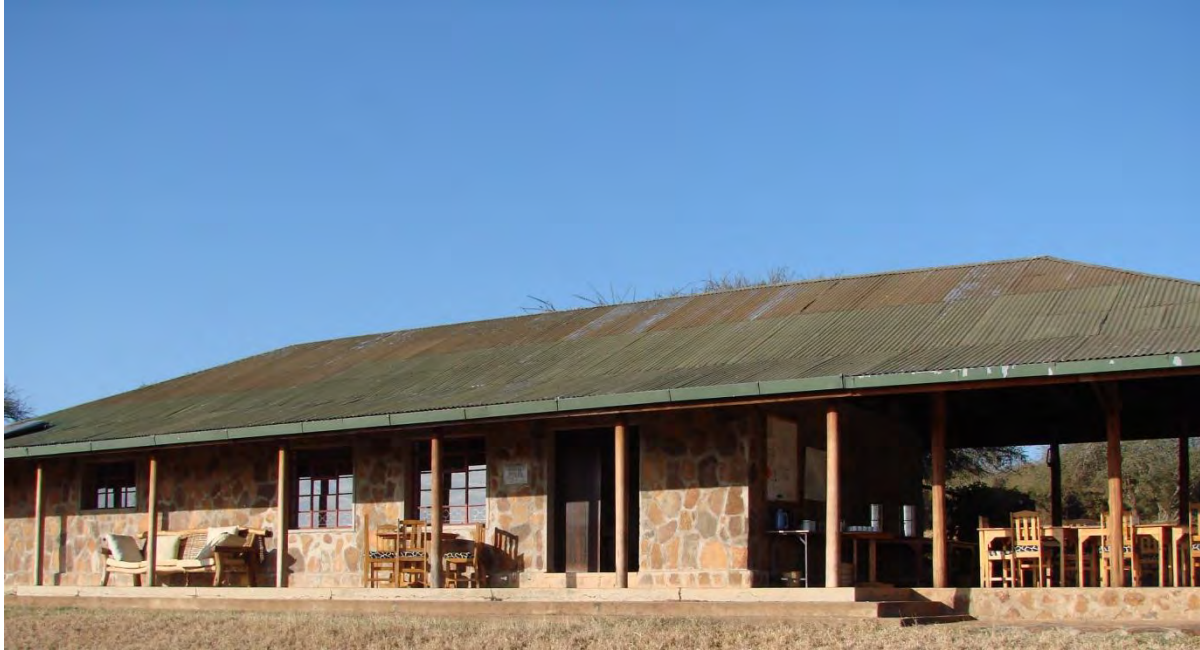
FIGURE 8: MESS HALL ROOF, SHOWING DEGRADATION AS A RESULT OF ANIMAL ACTIVITY. PHOTO BY AJAY VARADHARAJAN.

One of the cheapest and easiest ways for Mpala to increase the efficiency of their rooftop water harvesting system would be to drive birds and other animals away from the rooftops. These animals reduce the efficiency of the rooftops as a collection surface by scratching at and roughing up the surface of the roofing material (a smoother surface collects rain more efficiently), and their dropping also contain acids which degrade the roofing and diminish the lifetime of the roof. This is already apparent at Mpala on buildings like the Mess Hall, where the roof has been seriously degraded in parts (Figure 8, below). Additionally, their droppings can contaminate the water that enters the storage tanks with any number of bird-carried diseases, which restricts the amount of usable water collected at Mpala (Steed, 2008). The addition of bird and animal deterrents to the roofs would thus help to meet the objective of clean water collection system at Mpala.

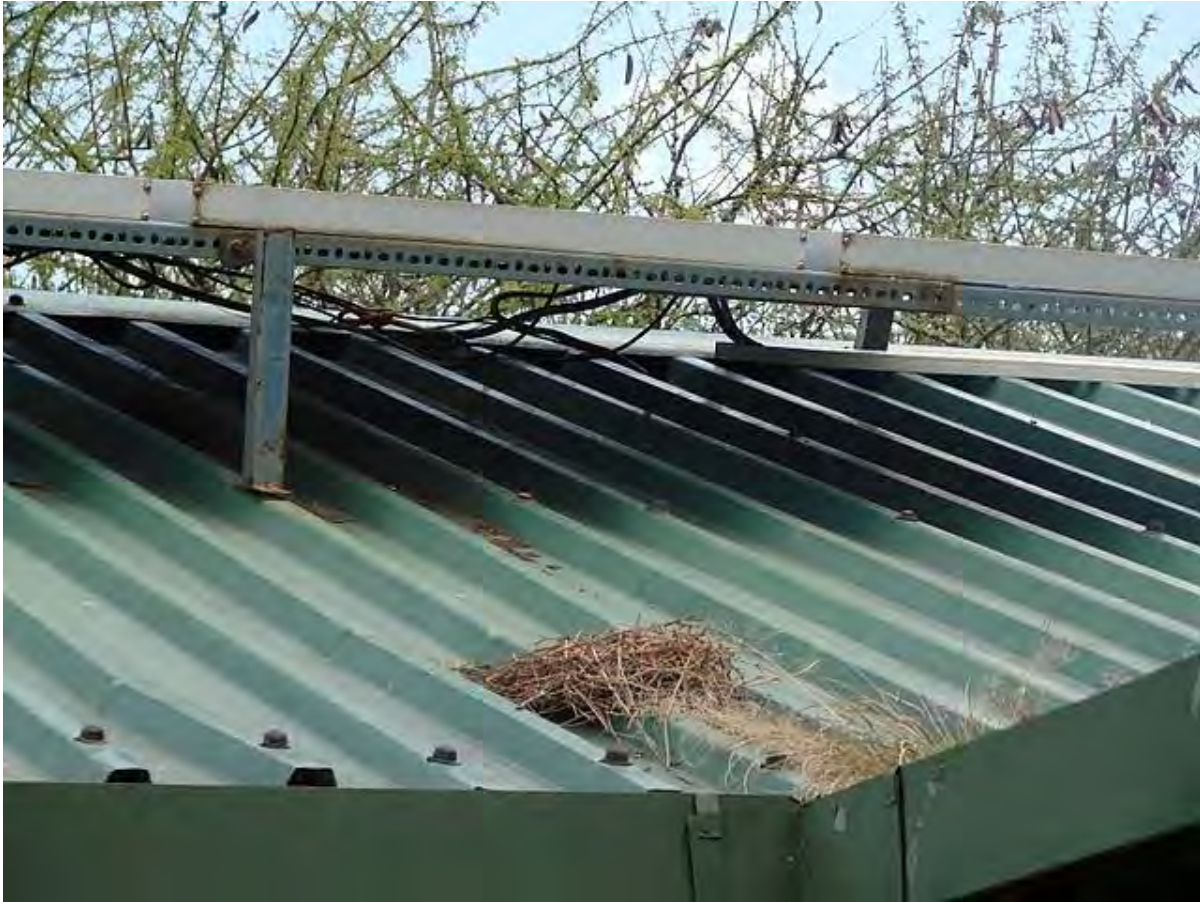
FIGURE 9: BIRDS' NESTS ON NSF LAB GUTTERS. PHOTO BY MELISSA ANTOKAL.

Mpala should likely only consider the first two of these types of deterrents on a large scale. Because the water in the storage tanks is intended for human consumption, adding a foul taste to the run-off is undesirable. Additionally, taste deterrents are designed to prevent animals like woodpeckers or squirrels from burrowing into wood surfaces, which is not the primary concern for Mpala. Physical barriers are designed for small areas, like on top of an air conditioning system or the ledge of a building, whereas the birds at Mpala congregate all along the rooftops. Covering the entire rooftop in bird spikes would likely be cost-prohibitive and aesthetically undesirable. For these reasons, we have only considered audio and visual deterrents in this report. However, Mpala should consider bird spikes on gutter areas where birds have been known to nest, such as on the NSF lab roof, as seen in Figure 9.

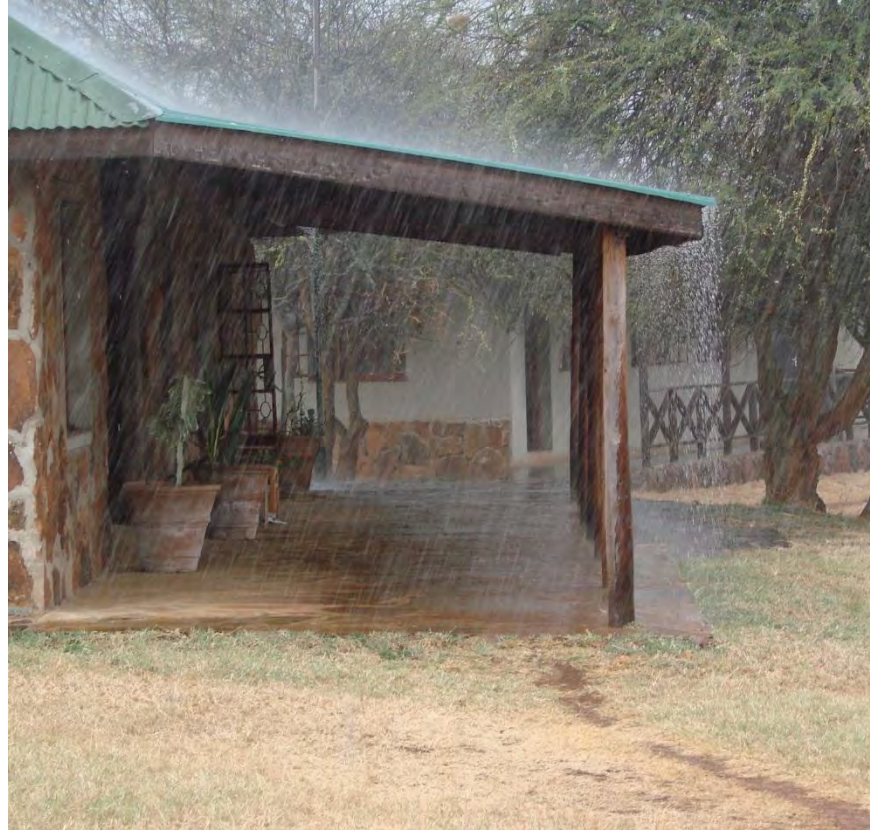
FIGURE 10: ADMINISTRATION BUILDING DURING A RAINSTORM, SHOWING LOST RUNOFF DUE TO INSUFFICIENT CONVEYANCE. PHOTO BY AJAY VARADHARAJAN.

Gutters and downspouts direct rain from the roof to cisterns or storage tanks (Kinkade-Levarios, 2007). Gutters are cheaper than new roofing, and Mpala should consider maximizing capture from each building by guttering those that are only partially guttered right now, such as the Administration Building and the Director's House (Figure 10 below).

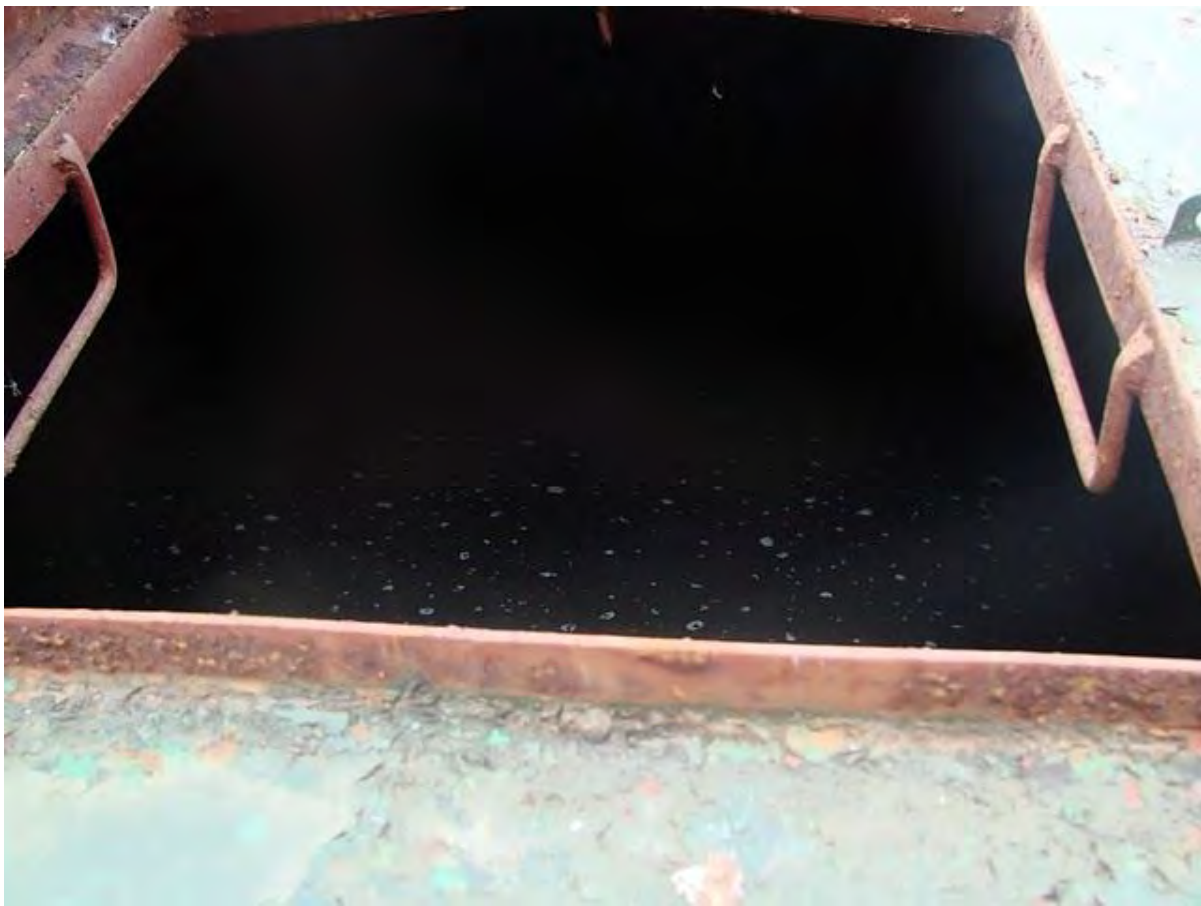
FIGURE 11: MOSQUITO LARVAE AND OTHER CONTAMINANTS IN SMALL TANK BY KITCHEN. PHOTO BY MELISSA ANTOKAL.

As observed at Mpala, mosquito larva may seriously compromise the quality of the water stored in some of the tanks (Figure 11). Many mosquitoes can be filtered out using fine mesh screens before water enters the cistern (Libba, “Other safety,” no date). The tank should have a tight-fitting cover to prevent mosquito or other pest infestation (Meganck, Rast, & Rodgers, 1997). Water that sits stagnant for a long period of time is more likely to become contaminated with bacteria, insects, or parasites.

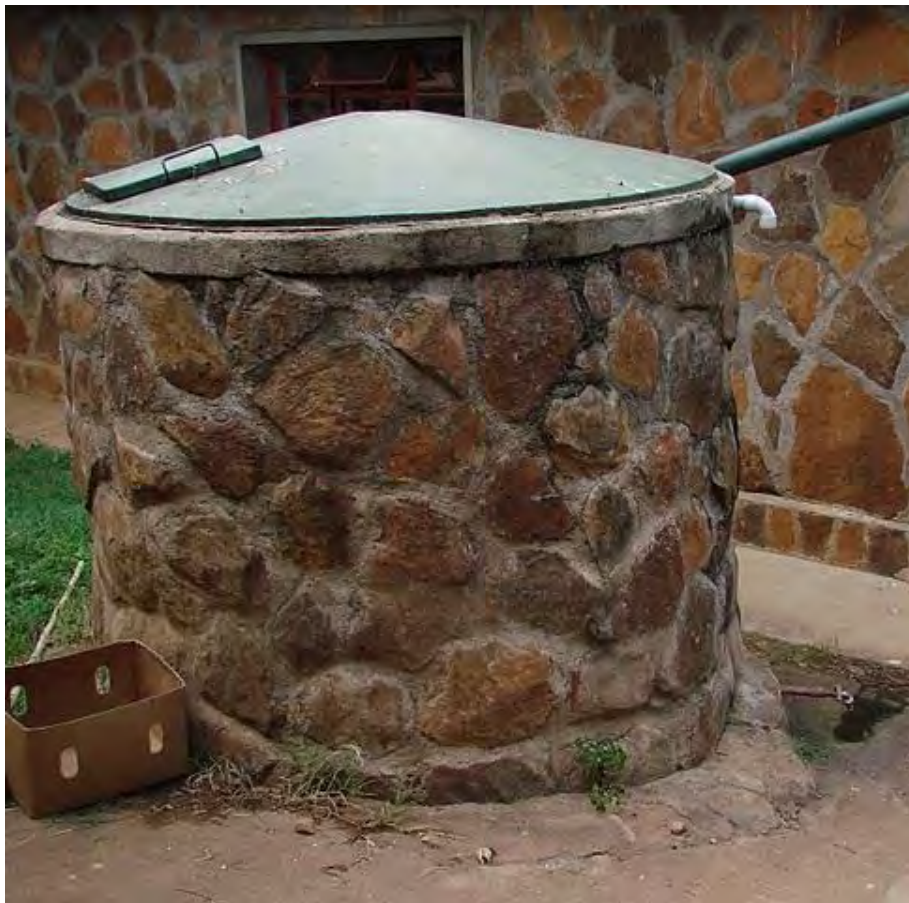
FIGURE 12: PLUMBING SET-UP FOR SMALL WATER TANK BY KITCHEN. PHOTO BY MELISSA ANTOKAL.

Because fine sediments will settle at the bottom of the tank, spouts for retrieving water should be no less than six inches (15 cm) above the bottom of the tank (Kinkade-Levario, 2007). There should also be a spout near the bottom of the tank for flushing the system (Pushard, no date). Figure 12 shows that the spouts used for drawing water currently are located near the bottom of tanks.

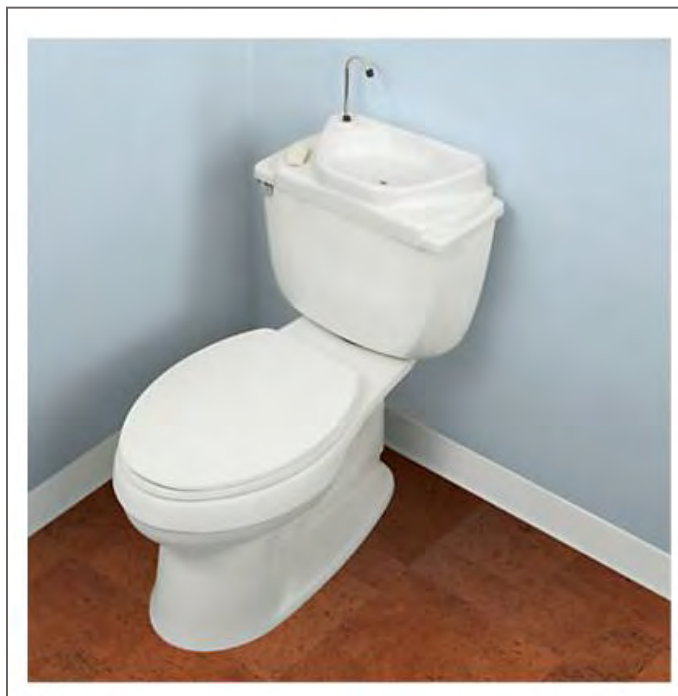
A system of reducing water use that could be explored further is the use of grey water. Grey water is wastewater generated from domestic activities such as laundry, dishwashing, and bathing which can be recycled on-site for uses (Cross, n.d.). At the MRC, this on-site use is most likely limited to toilet water. Therefore, water used for hand washing can be reused in toilet flushing. For toilet flushing, after the dual flush option is in place, up to 24 liters per person per day can be saved from the borehole. When the Centre is at capacity, 888 liters of water per day can be saved. There are two options for implementing this type of grey water system, one of which would include a new plumbing system. The other would be a product such as the toilet lid sink by Gaiaam (2011). This product, with retail prices starting at ~\$90.00 each, has a hand washing sink above the toilet tank. This allows the toilet to be refilled

with the water used to wash the hands of the previous visitor (see product below). A future group or the managers at Mpala may want to consider this option in the future.

FIGURE 13: TOILET LID SINK. SOURCE: GAIAM WEBSITE.

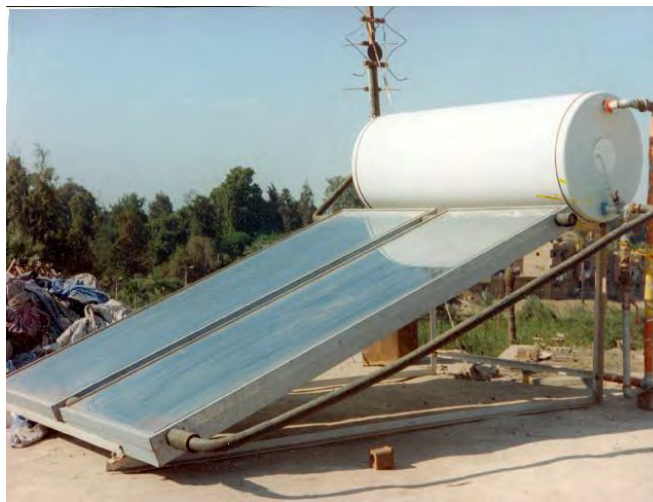
A solar thermal water system at Mpala is best accomplished as rooftop systems. This will minimize the disturbance of the land around the buildings and allow more ground surface for rainwater collection systems. With the minimized occurrence of elephant traffic due to the new fence around the Centre, the ground can also be an option for these systems.

The panels that are available come in standard sizes, according to Mpala's local supplier. The most ideal size for the panels are 2.3m<sup>2</sup> (smallest available). The tanks are at 220 liters, for adequate roof installation. The Centre will only need approximately 11 tanks at full capacity, approximately one per building, with more for the buildings that hold more guests.

FIGURE 14: SOLAR THERMAL WATER HEATING SYSTEM. IMAGE FROM UNDP GEF SMALL GRANTS PROGRAMME.

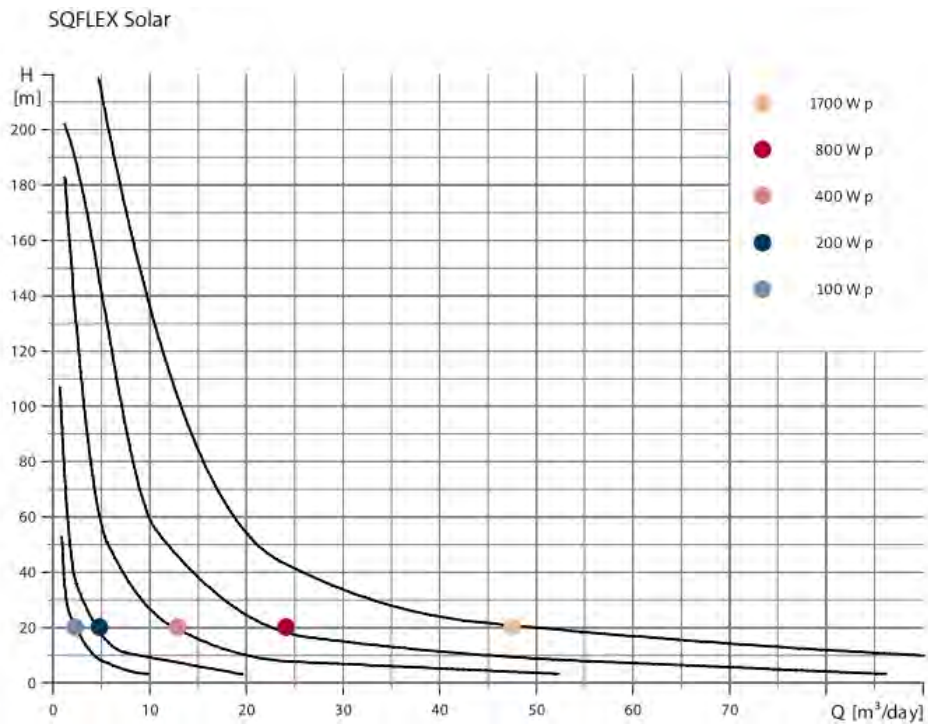
The SQFlex Solar performance curves

A photovoltaic pump can be purchased in Kenya by a company headquartered in Denmark, Grundfos. This has several sizes of pumps that are designed to pump a certain amount of water per day over a maximum vertical distance. The largest pump available is a 1700 Watt system, which can pump up to 17.5 cubic meters of water 70 meters in one day. Unfortunately, that does not meet the current specifications needed to pump the current demand at Mpala. However, if Mpala replaces its drinking water with rainwater, and installs low-flow fixtures within the recommended parameters outlined in this report, the 1700 Watt system would be more than enough needed for Mpala's borehole water demand.

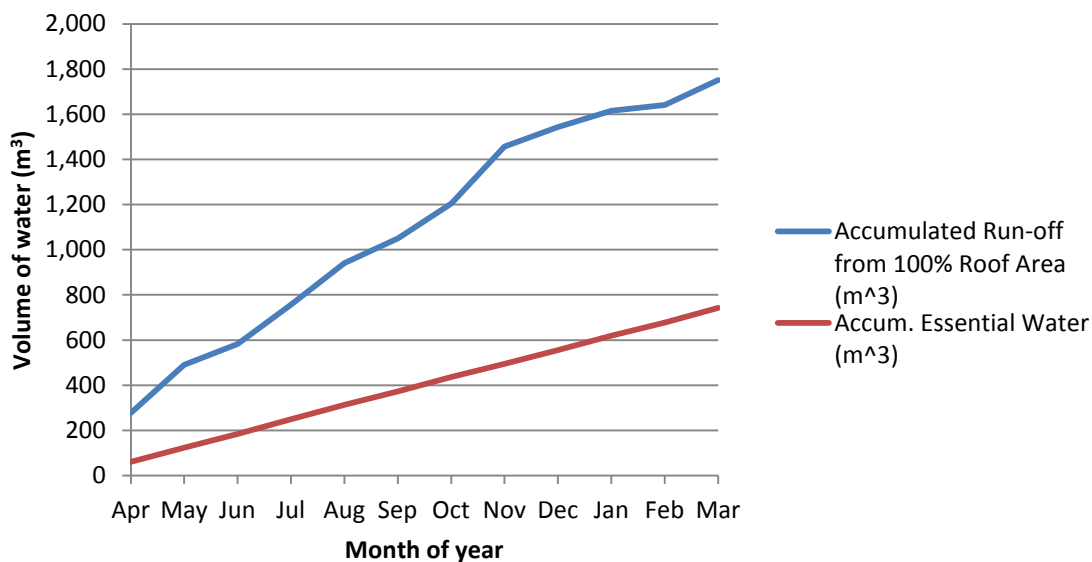
**Graph 1: Accumulated run-off ( $\text{m}^3$ ) and essential water required ( $\text{m}^3$ ) for 100% roof area and current population in an average rainfall year**

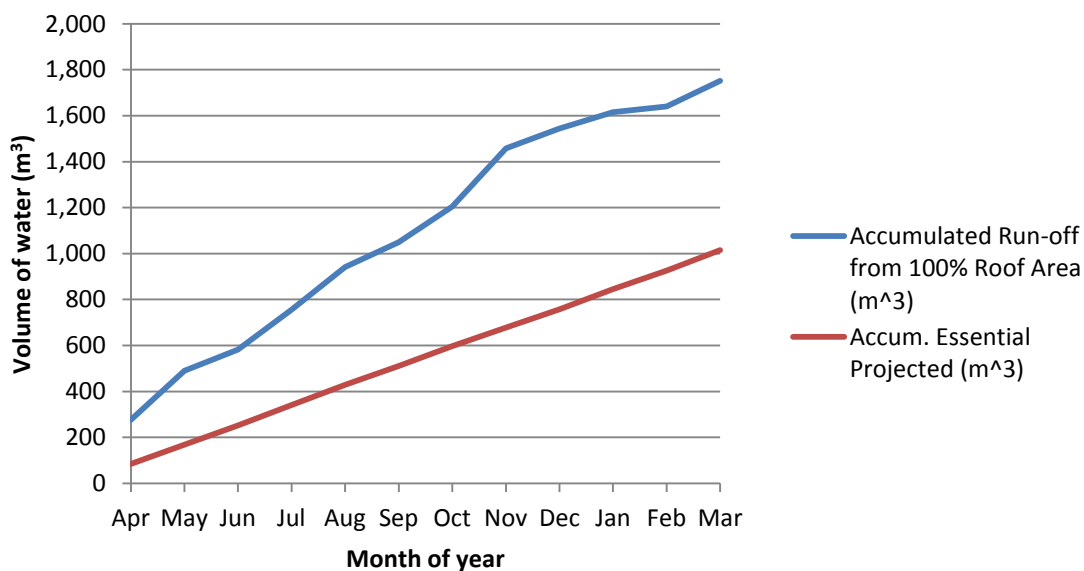
**Graph 2: Accumulated run-off ( $\text{m}^3$ ) and essential water required ( $\text{m}^3$ ) for 100% roof area and projected population in an average rainfall year**

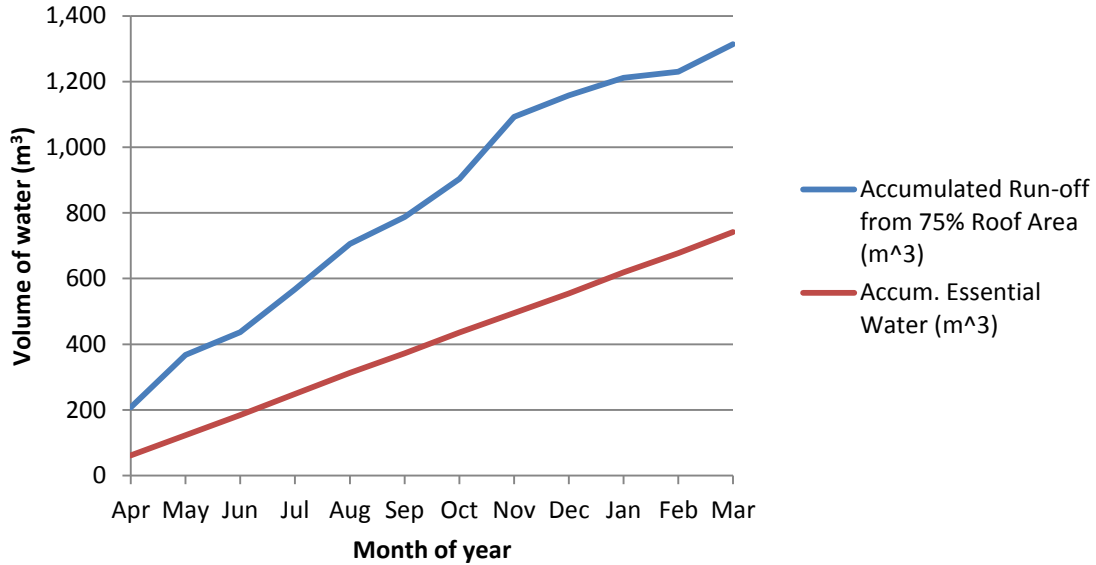
**Graph 3: Accumulated run-off ( $\text{m}^3$ ) and essential water required ( $\text{m}^3$ ) for 75% roof area and current population in an average rainfall year**

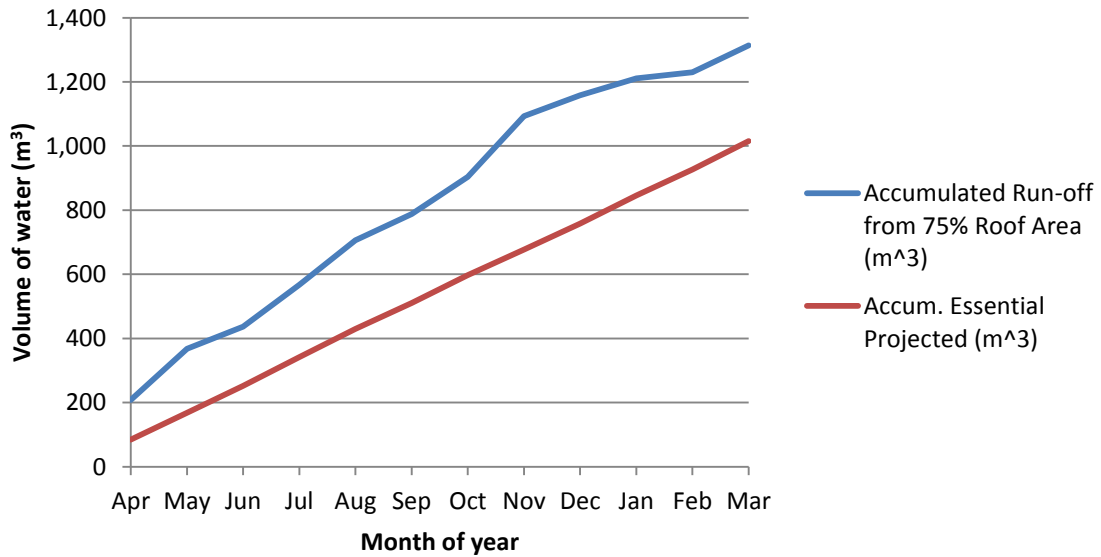
**Graph 4: Accumulated run-off ( $\text{m}^3$ ) and essential water required ( $\text{m}^3$ ) for 75% roof area and projected population in an average rainfall year**

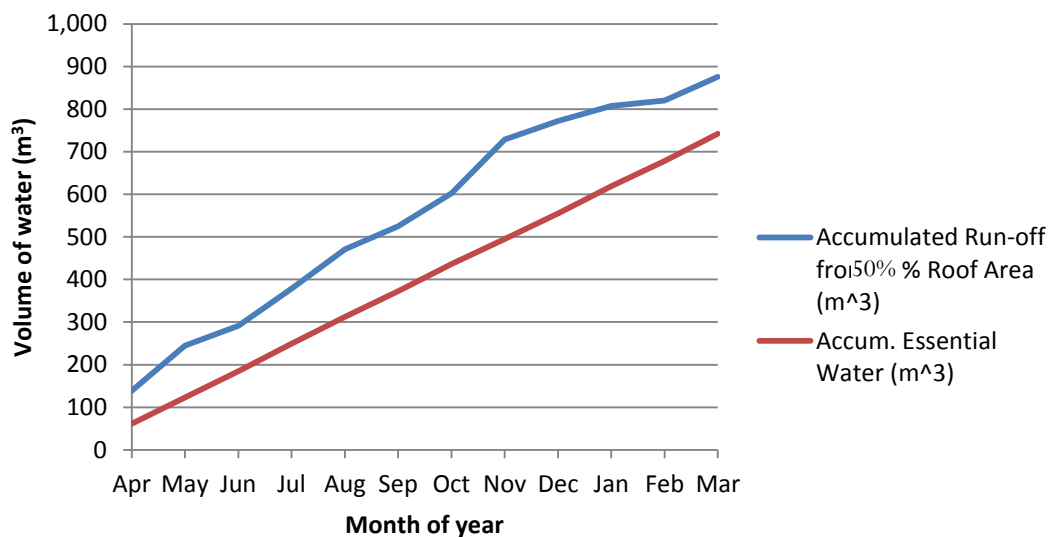
**Graph 5: Accumulated run-off ( $m^3$ ) and essential water required ( $m^3$ ) for 50% roof area and current population in an average rainfall year**

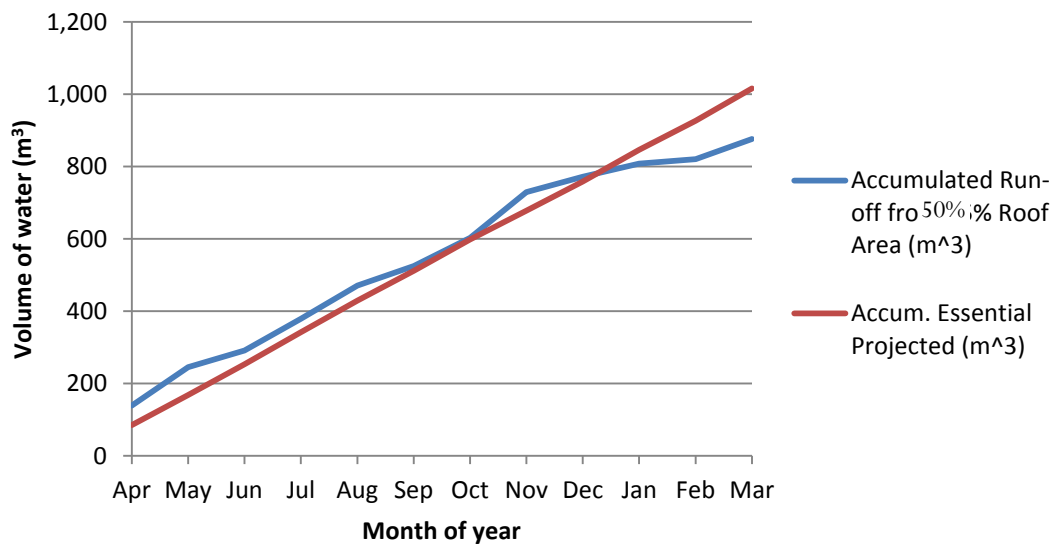
**Graph 6: Accumulated run-off ( $m^3$ ) and essential water required ( $m^3$ ) for 50% roof area and projected population in an average rainfall year**

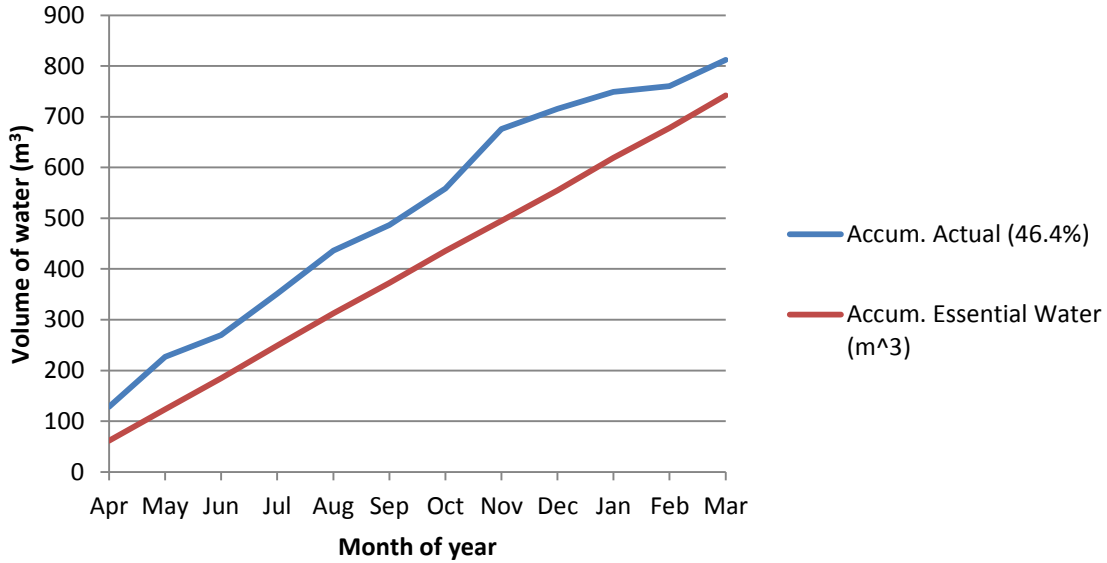
**Graph 7: Accumulated run-off ( $\text{m}^3$ ) and essential water required ( $\text{m}^3$ ) for current converted roof area (46.4%) and current population in an average rainfall year**

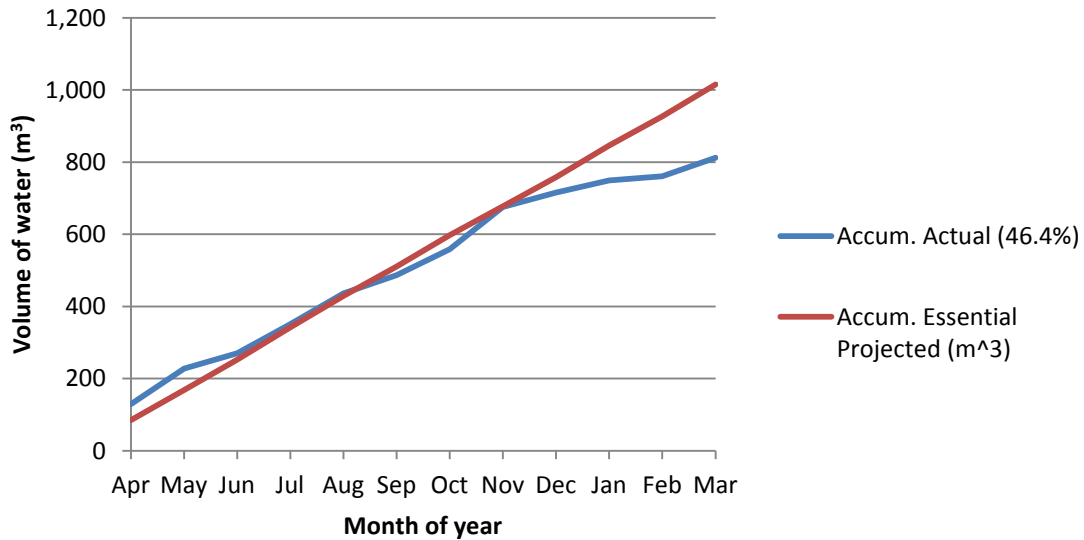
**Graph 8: Accumulated run-off ( $\text{m}^3$ ) and essential water required ( $\text{m}^3$ ) for current converted roof area (46.4%) and projected population in an average rainfall year**

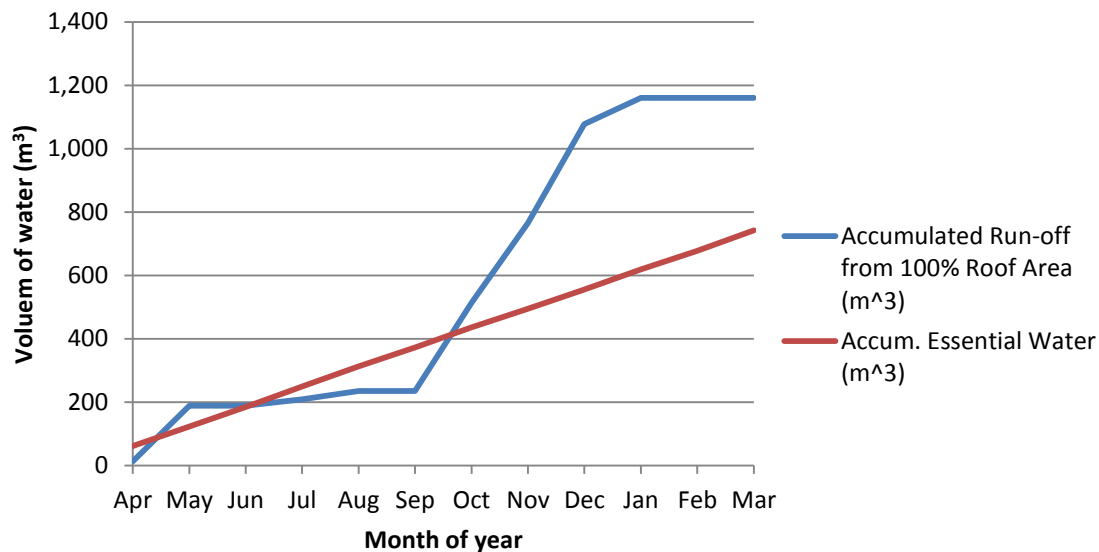
**Graph 9: Accumulated run-off ( $m^3$ ) and essential water required ( $m^3$ ) for 100% roof area and current population in a low rainfall year**

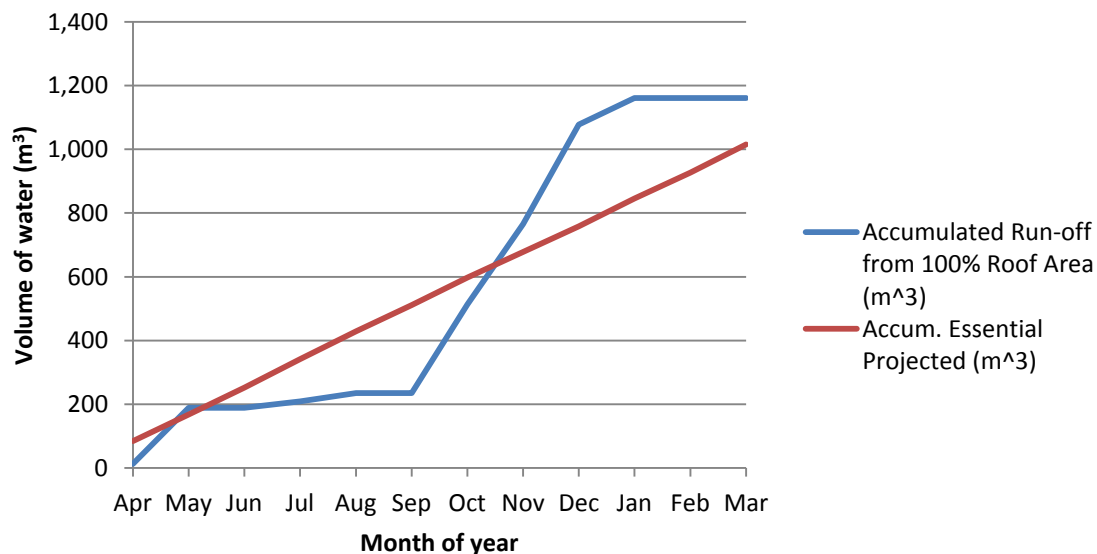
**Graph 10: Accumulated run-off ( $m^3$ ) and essential water required ( $m^3$ ) for 100% roof area and projected population in a low rainfall year**

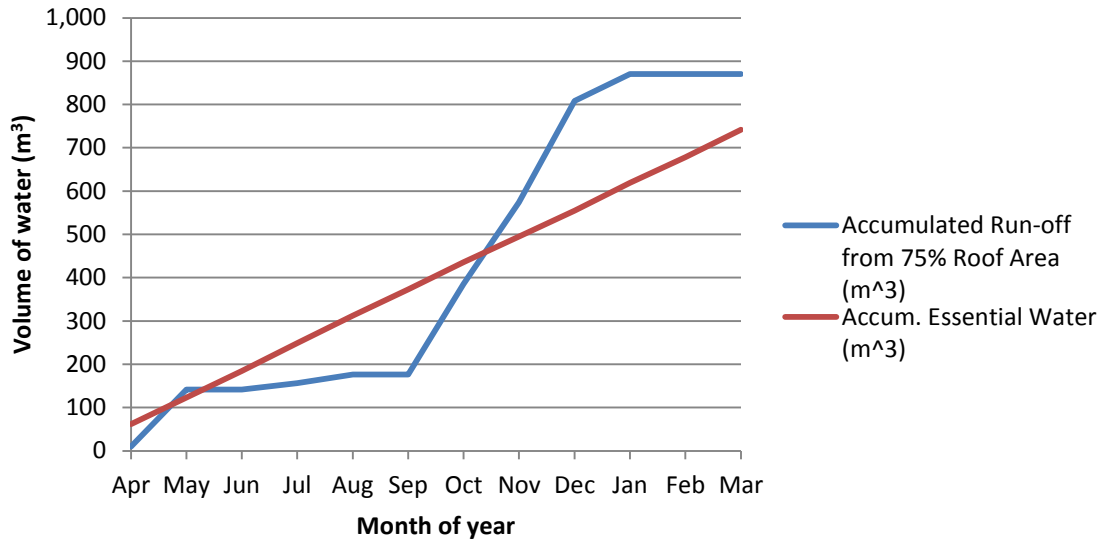
**Graph 11: Accumulated run-off ( $\text{m}^3$ ) and essential water required ( $\text{m}^3$ ) for 75% roof area and current population in a low rainfall year**

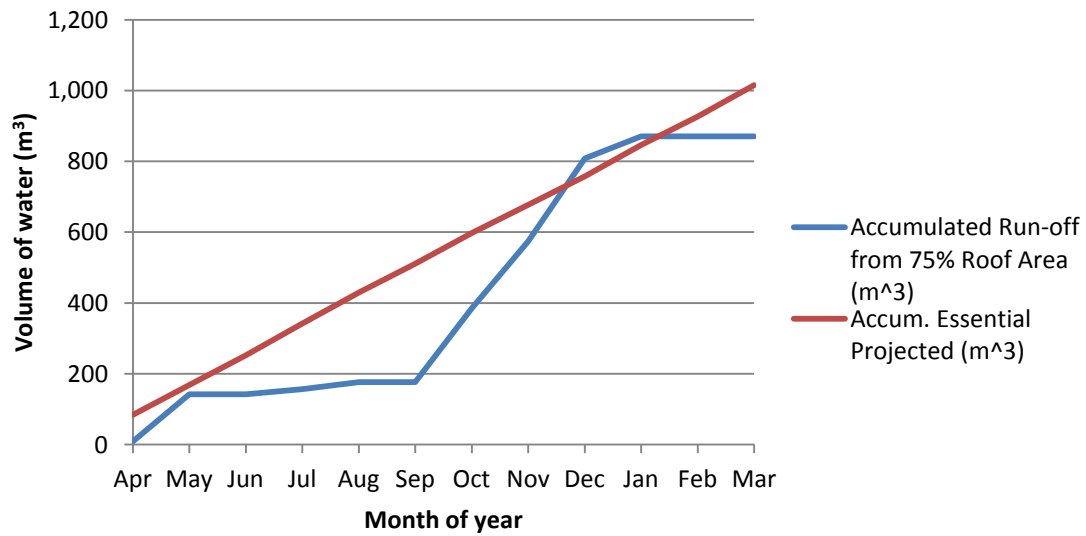
**Graph 12: Accumulated run-off ( $\text{m}^3$ ) and essential water required ( $\text{m}^3$ ) for 75% roof area and projected population in a low rainfall year**

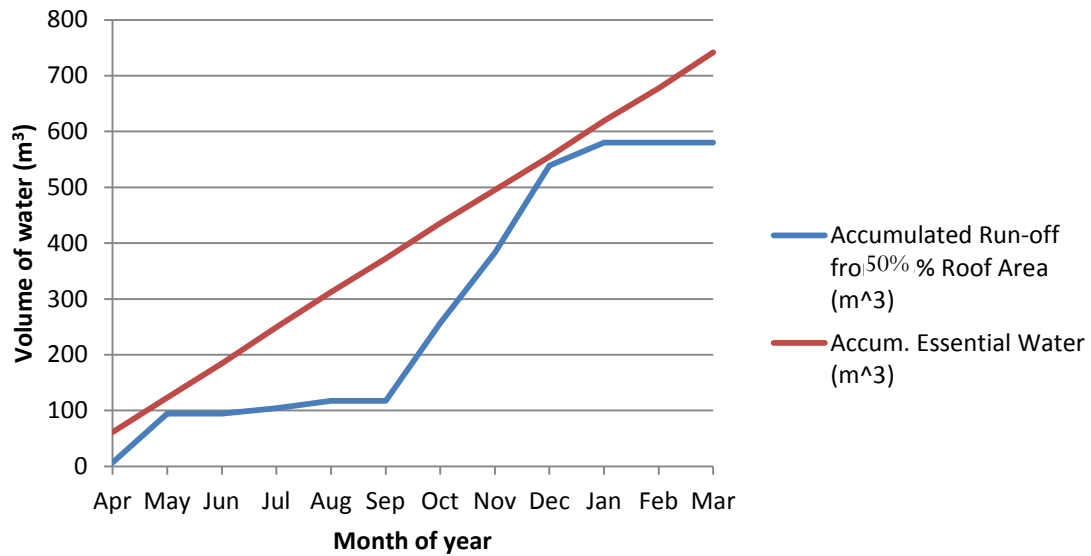
**Graph 13: Accumulated run-off ( $m^3$ ) and essential water required ( $m^3$ ) for 50% roof area and current population in a low rainfall year**

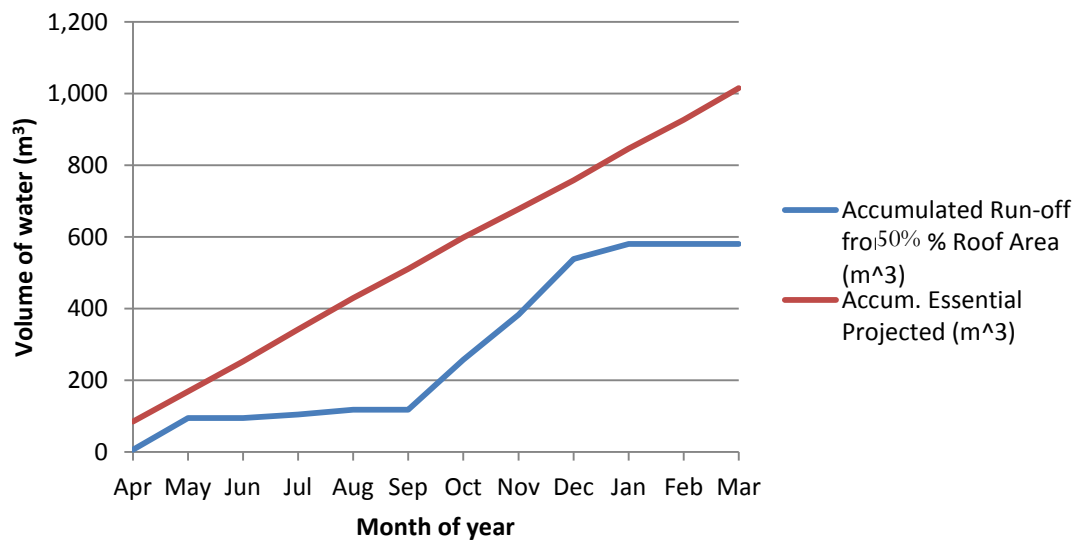
**Graph 14: Accumulated run-off ( $m^3$ ) and essential water required ( $m^3$ ) for 50% roof area and projected population in a low rainfall year**
