# Building a Sustainable Community in Africa

Water Sustainability at the Mpala Research Centre and Conservancy

**A PROJECT SUBMITTED IN PARTIAL FULFILLMENT OF THE REQUIREMENTS FOR THE  
DEGREE OF MASTER OF SCIENCE (NATURAL RESOURCES AND ENVIRONMENT) AT THE  
UNIVERSITY OF MICHIGAN**

2011

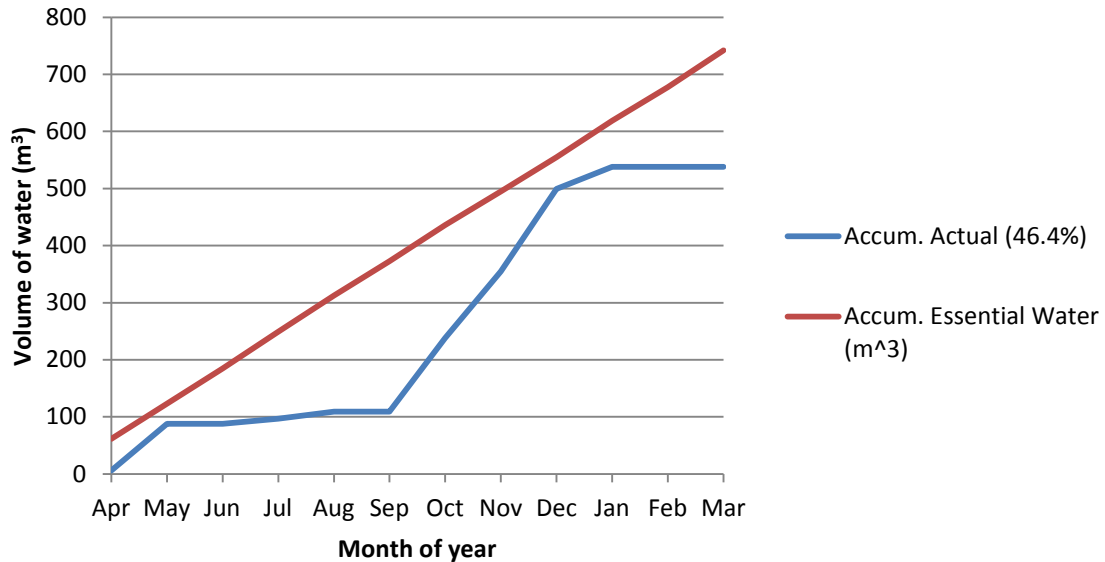
**Graph 15: Accumulated run-off ( $\text{m}^3$ ) and essential water required ( $\text{m}^3$ ) for current converted roof area (46.4%) and current population in a low rainfall year**

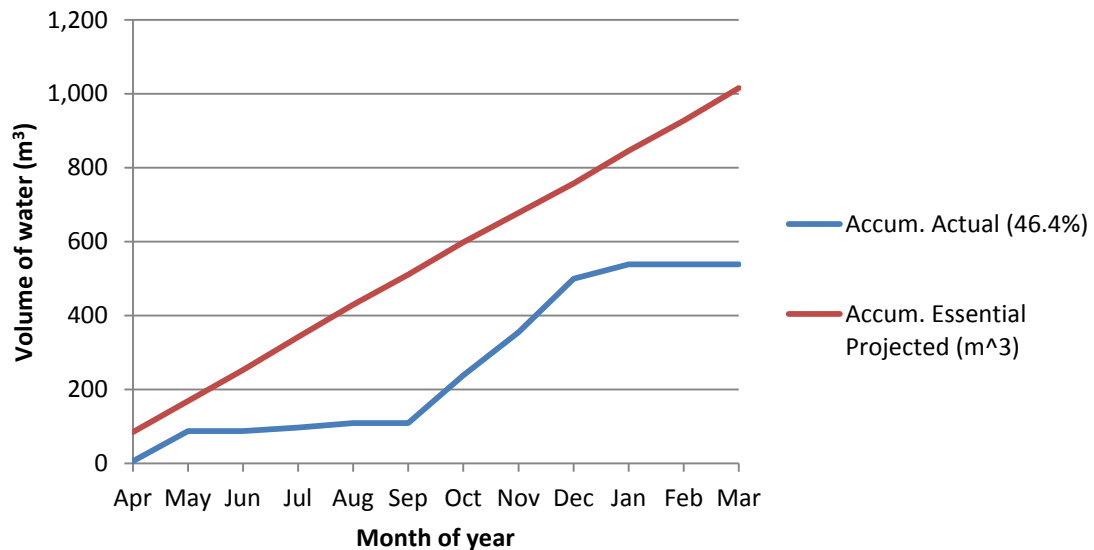
**Graph 16: Accumulated run-off ( $\text{m}^3$ ) and essential water required ( $\text{m}^3$ ) for current converted roof area (46.4%) and projected population in a low rainfall year**

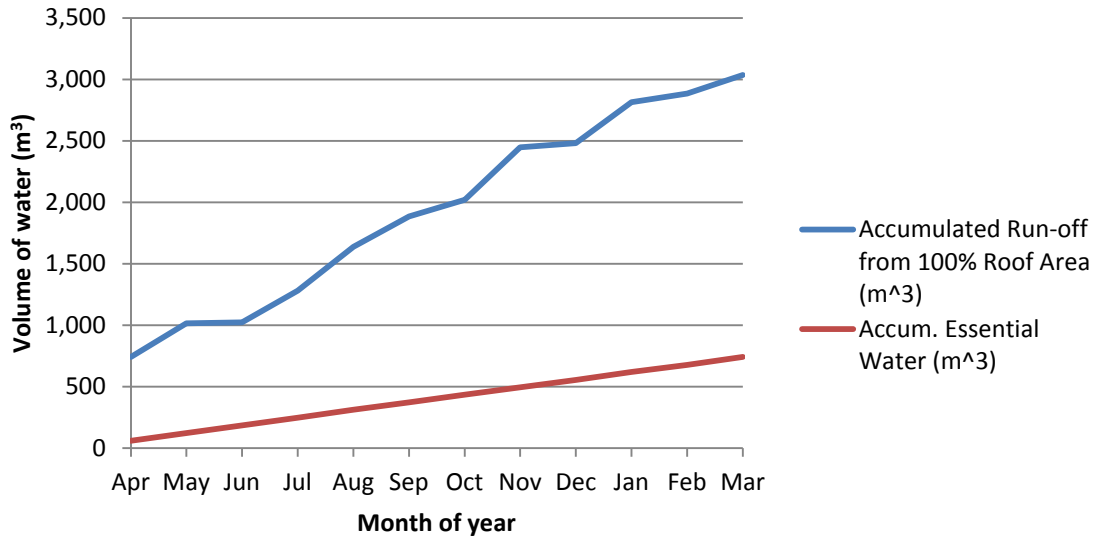
**Graph 17: Accumulated run-off ( $m^3$ ) and essential water required ( $m^3$ ) for 100% roof area and current population in a high rainfall year**

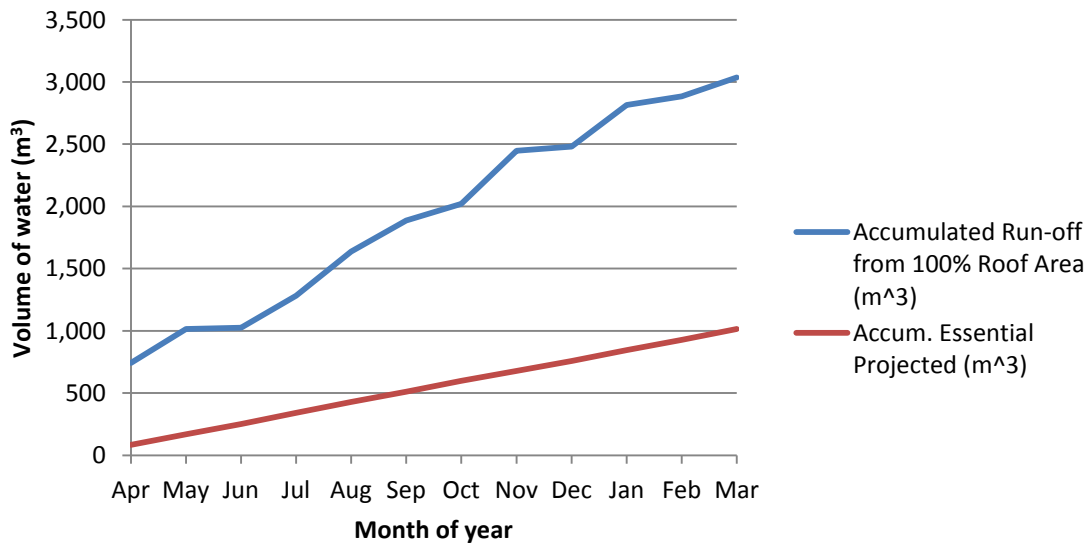
**Graph 18: Accumulated run-off ( $m^3$ ) and essential water required ( $m^3$ ) for 100% roof area and projected population in a high rainfall year**

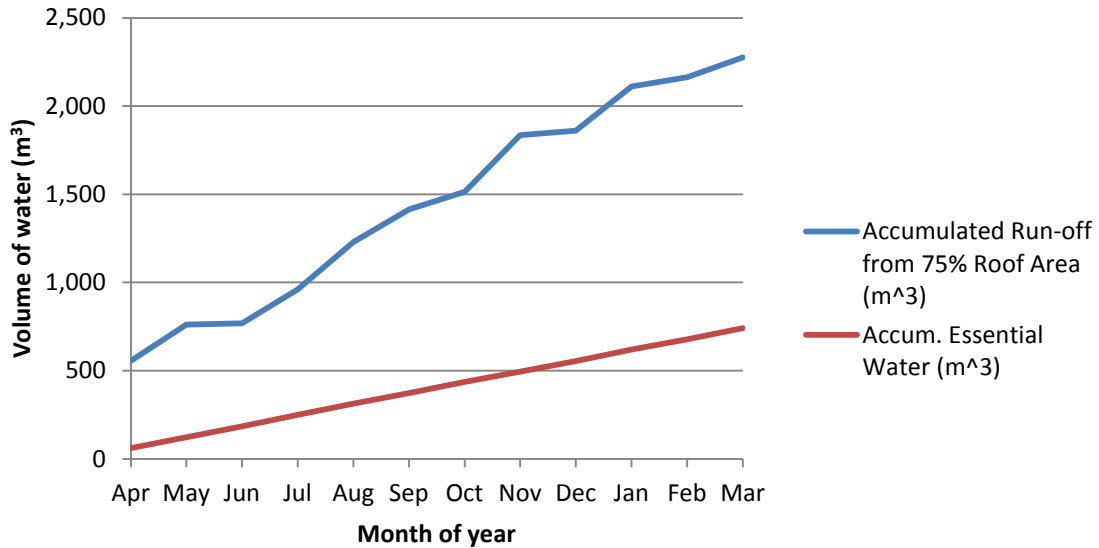
**Graph 19: Accumulated run-off ( $\text{m}^3$ ) and essential water required ( $\text{m}^3$ ) for 75% roof area and current population in a high rainfall year**

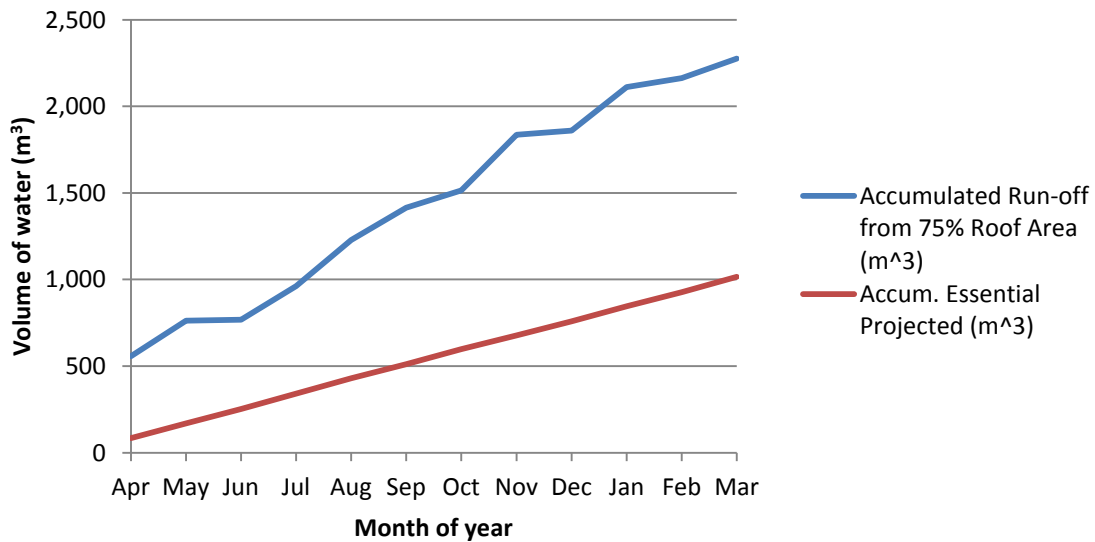
**Graph 20: Accumulated run-off ( $\text{m}^3$ ) and essential water required ( $\text{m}^3$ ) for 75% roof area and projected population in a high rainfall year**

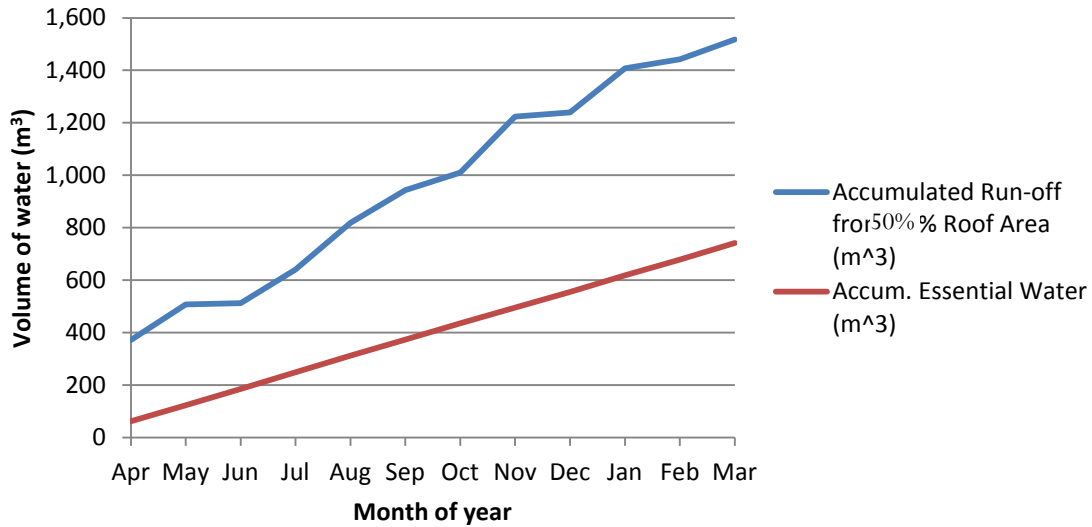
**Graph 21: Accumulated run-off ( $m^3$ ) and essential water required ( $m^3$ ) for 50% roof area and current population in a high rainfall year**

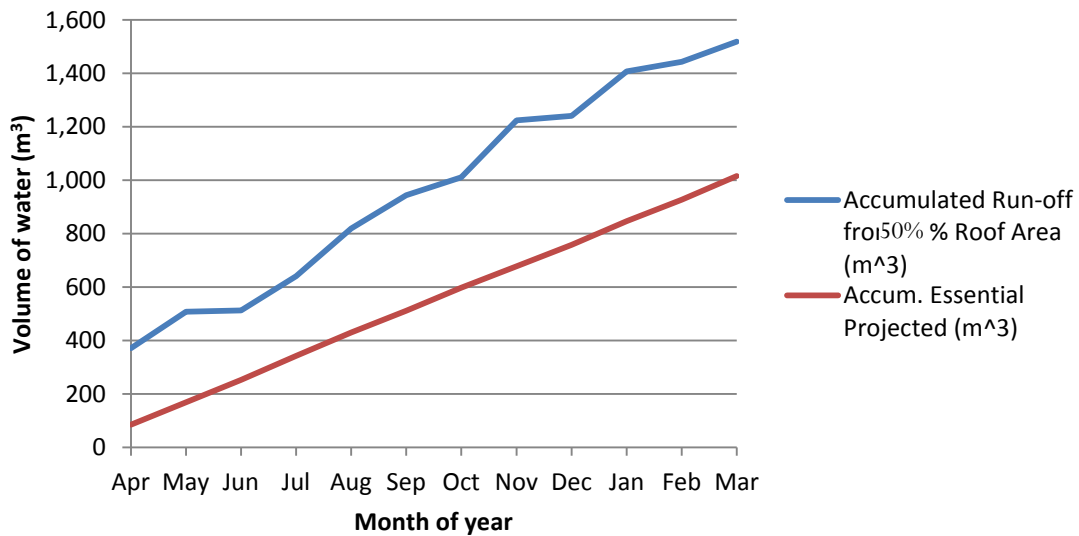
**Graph 22: Accumulated run-off ( $m^3$ ) and essential water required ( $m^3$ ) for 50% roof area and projected population in a high rainfall year**

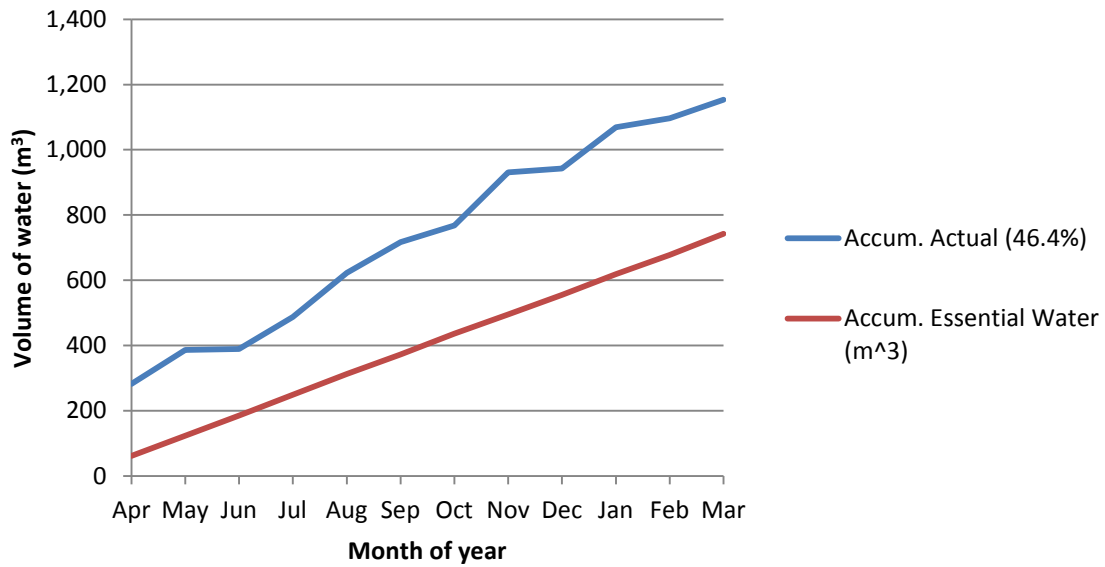
**Graph 23: Accumulated run-off ( $\text{m}^3$ ) and essential water required ( $\text{m}^3$ ) for current converted roof area (46.4%) and current population in a high rainfall year**

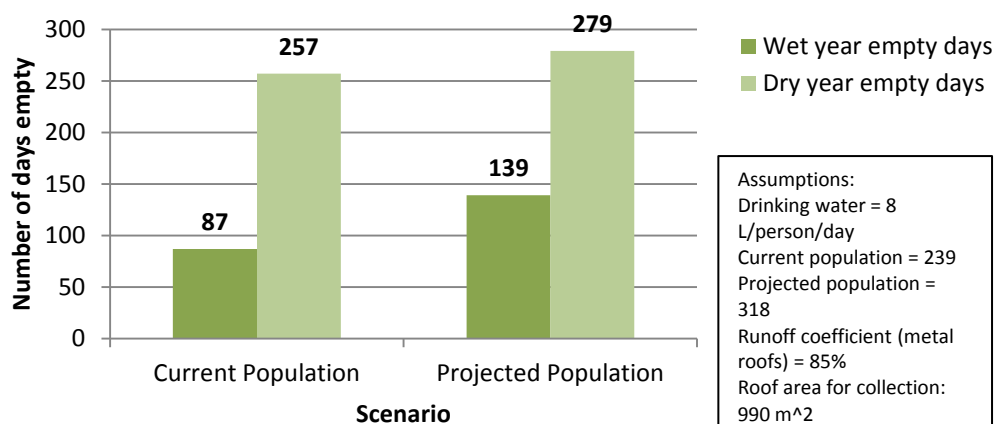
**Comparison of 1000-liter tanks at every Village home serving current Village Population and Projected 33% increase in Village Population**

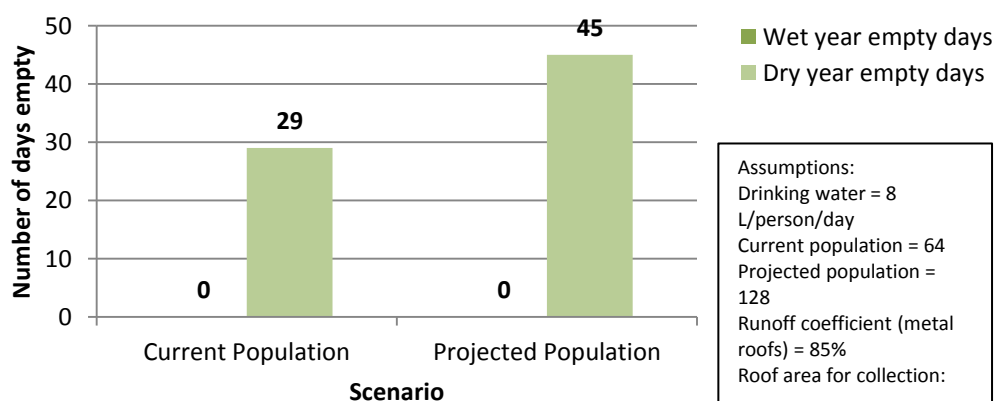
**Comparison of Current Storage Capacity and Current Roof Catchment Serving Current and Projected 100% Increase of Visitor Population**

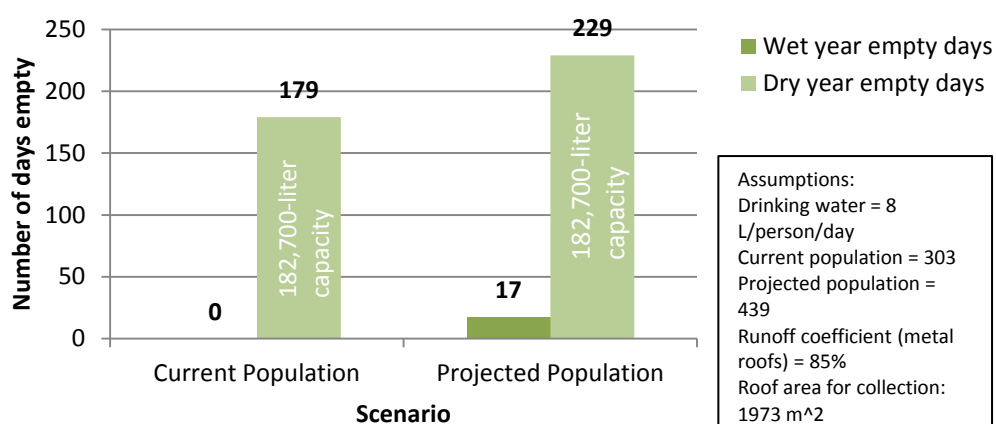
**Comparison of Current Storage Capacity and Current Roof Catchment Serving Current and Projected Total MRC Population**

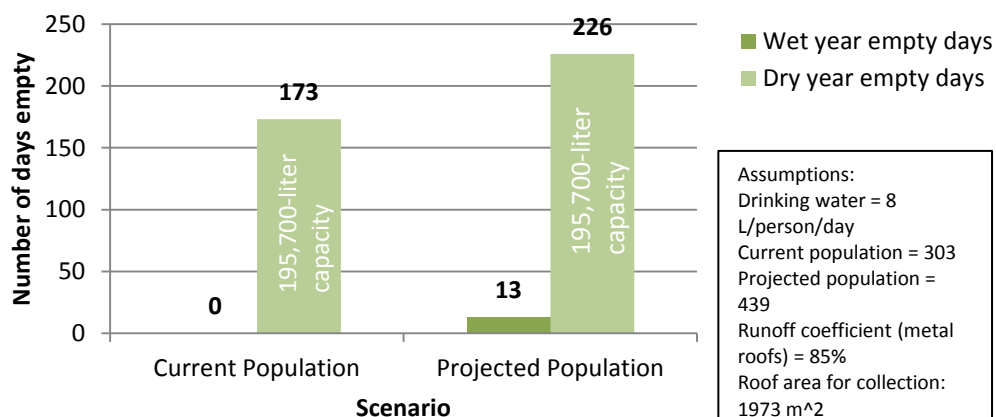
**Comparison of Current Roof Catchment and Current Storage plus (1) Additional 13 m<sup>3</sup> Tank Serving Current and Projected Total MRC Population**

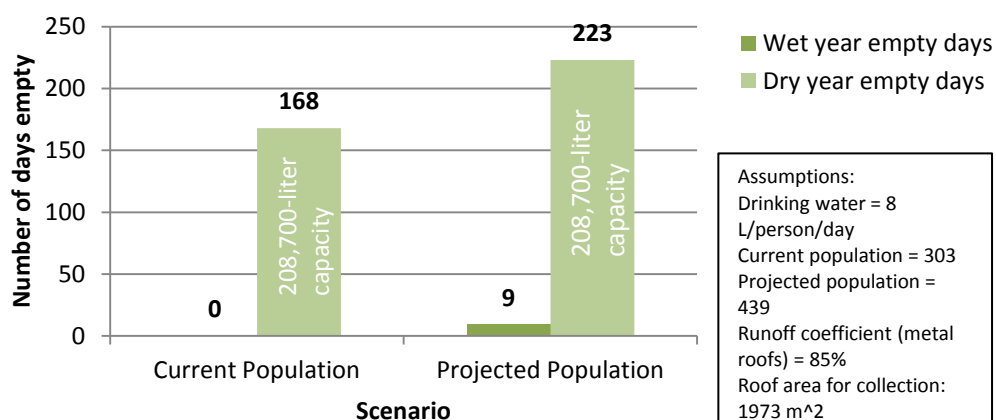
**Comparison of Current Roof Catchment and Current Storage plus (2) Additional 13 m<sup>3</sup> Tanks Serving Current and Projected Total MRC Population**

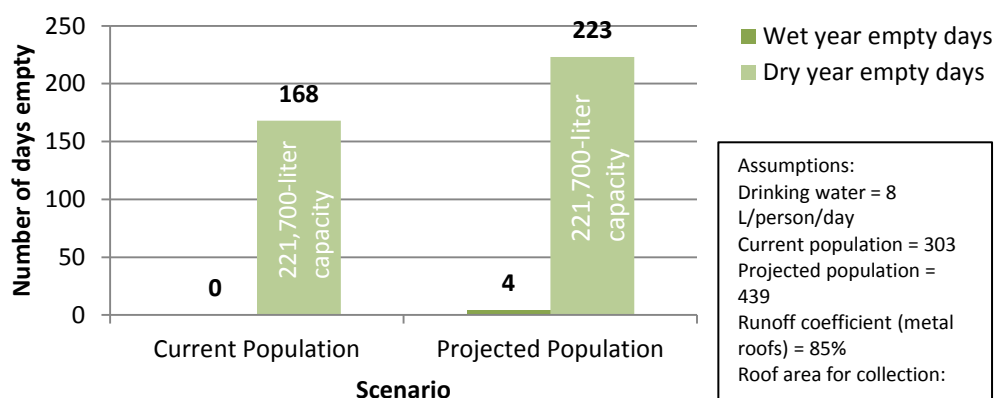
**Comparison of Current Roof Catchment and Current Storage plus (3) Additional 13 m<sup>3</sup> Tanks Serving Current and Projected Total MRC Population**

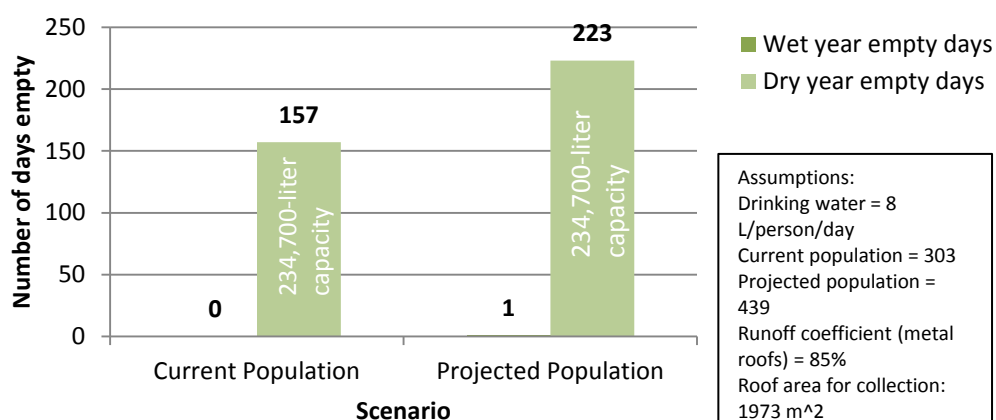
**Comparison of Current Roof Catchment and Current Storage plus (4) Additional 13 m<sup>3</sup> Tanks Serving Current and Projected Total MRC Population**

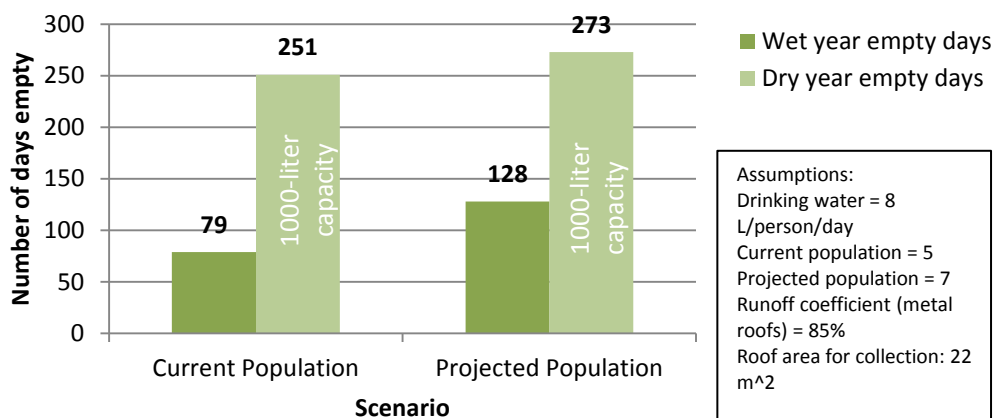
**Comparison of 1 Village House Roof and 1000 liter tank serving 1 current village family or 1 village family plus projected population increase of 33%**

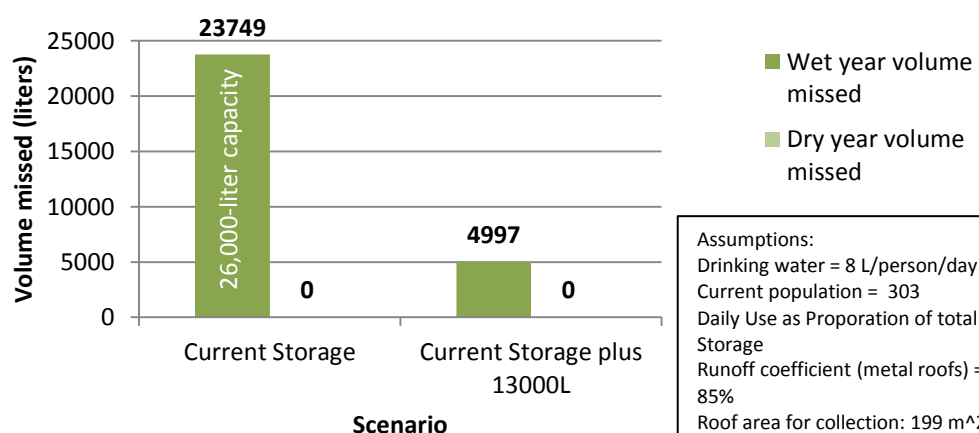
**Volume Missed from Library Building Roof with Current Storage and Current Storage plus (1) 13000 Liter Tank (Serving Current Population)**

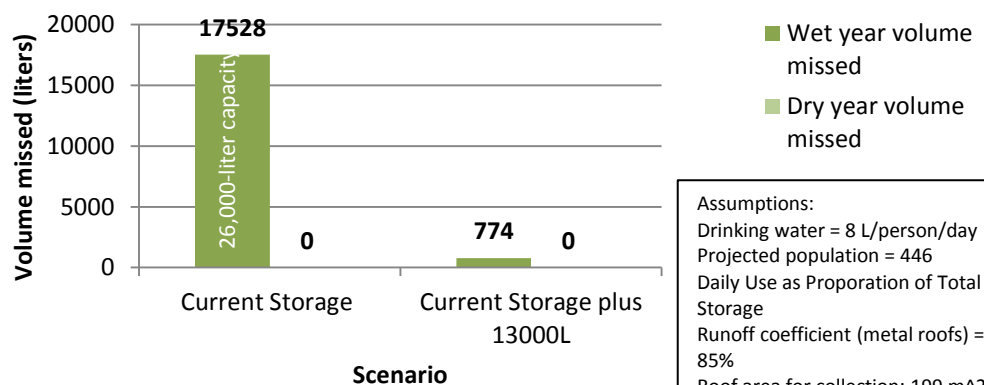
**Volume Missed from Library Building Roof with Current Storage and Current Storage plus (1) 13000 Liter Tank (Serving Projected Population)**
